Herrington Lake Bridge – Lowering of a 200-ft Caisson

DAVID ROGOWSKI, P.E., AND JOSH CRAIN, P.E., S.E., Genesis Structures Inc., Kansas City, MO and DOUG VANSLAMBROOK, Walsh Construction, Irving, TX, KEVIN BUCH, P.E., Walsh Construction, Harrodsburg, KY

IBC-18-76

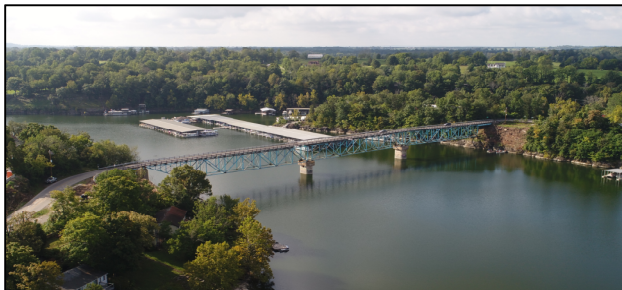
Photo 1 – Existing Truss Structure

The existing deck span structures (See Photo 1 and Photo 2) were considered beyond repair by the Kentucky Transportation Cabinet Department of

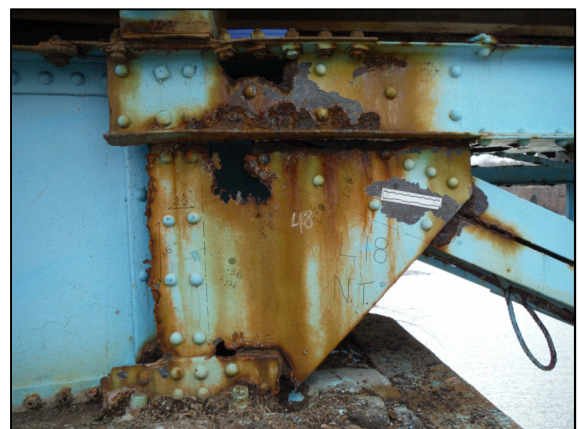
Photo 2 – Existing Truss in Poor Condition

Highways (KYTC), and a new structure was determined necessary. The new structure is to be located just off alignment of the existing bridge and will be built while the existing structure remains in service.

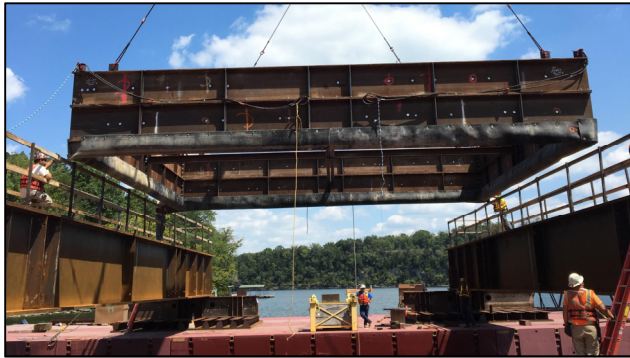
Photo 5 – Steel frame used to form the tremie concrete above the bottom of the lake

+Due to the water depths and dangers and inefficiencies associated with sending divers to the bottom of the lake, the construction team decided to employ a tremie seal. To contain the concrete, a 36-ft x 36-ft x 5-ft box consisting of W30's stacked together (refer to Photo 5 above) was lowered with the casings and eventually came to rest on the bottom. During the pour, the casings were held approximately 4-ft above rock. The concrete was placed through one casing via tremie pipe and monitored through three other casings using sounding tapes. Once the concrete level was at least 5-ft above the rock, the system was lowered into the plastic concrete until one casing contacted the rock bottom. The system was then adjusted with the strand jacks to achieve the very stringent verticality tolerance of 0.5%. A minimum amount of load was transferred to the rock, and then the countdown began. A small crew camped out on the barges periodically surveyed the pier to ensure there was no movement throughout the night. Note that the water level was controlled with the dam operations during this critical phase of construction. The surveys were performed to check for movement of the radial bearing plates (refer to Photo 6 above) in the tremie concrete. Field cured cylinders were stored in a cure

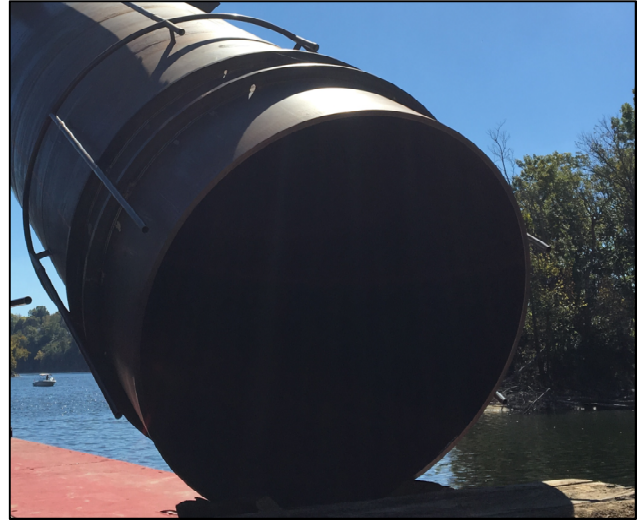
Photo 6 - Radial Bearing PL Added to Permanent Casing for Shear Load Transfer to Tremie Concrete

Final load transfer of the casing load between the strand jacks to the rock bed required an ability to maintain both horizontal and vertical alignment of the pier casings. Vertical load transfer from the strand jacks was achieved by pouring a 40-ft x 40-ft x 5-ft concrete tremie footing above the lake bed rock after the casing was lowered into its final position. The tremie footing was formed with a steel frame suspended from the underwater lowering frame. The tremie frame was equipped with a rubber seal along the bottom edge to prevent leaking of tremie concrete (See Photo 5). The permanent steel casings were again modified to include (2) levels of 4" radial "donut" bearing plates to transfer the load from the casing to the tremie concrete (See Photo 6)

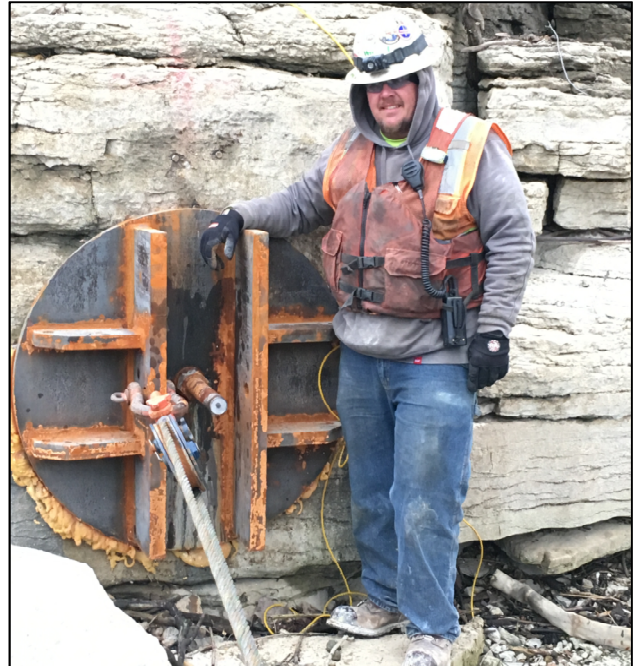
Photo 7 - Rock anchor used for barge horizontal alignment

Due to the natural contours of Herrington Lake, +/-700-ft width and +/-200-ft minimum depth with steep shoreline drop-offs, conventional barge spudding was not feasible to maintain horizontal alignment of the pier construction flotilla. The horizontal alignment of the flotilla was achieved using a series of +/-400-ft 1-1/4" Dia. cable braces extending from the barges to rock anchors drilled in at the shore line (See Photo 7).

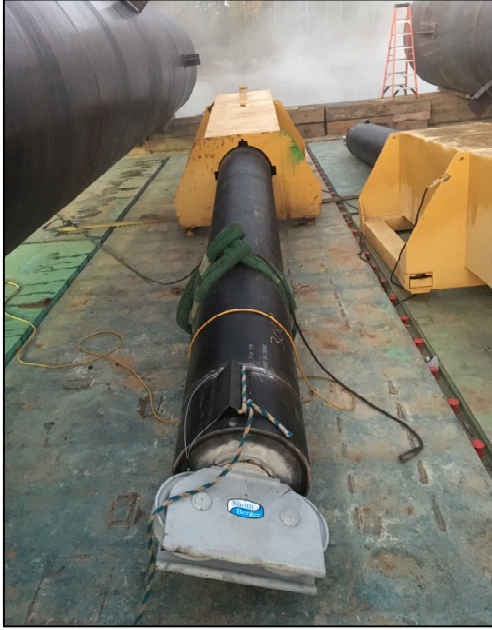
Photo 8 – 20-ft downrigger used to anchor the barge below water level to avoid boat traffic

One challenge in securing the alignment cables to the barges was a requirement to maintain the cables +/-20-ft below the water level to minimize impact on local boat traffic. A 20-ft downrigger was conceived that attached at the barge deck level and guided the alignment cables through deck mounted winches down to a custom fairlead system (See Photo 8).

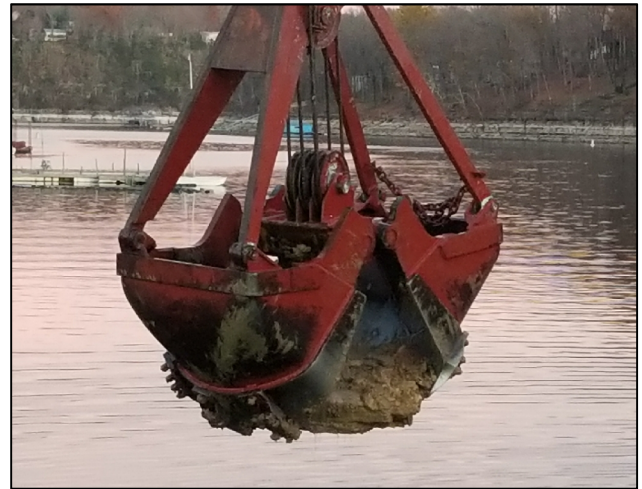
Photo 9 – 2.5CY Clamshell Bucket

The lake is approximately 200-ft deep at the center pier location, however, the actual depth of silty-clay overburden was less than 10-ft. The volume of material required to be removed to expose the rock bottom was approximately 1000cy. Although this is not an extraordinary volume, the fact that the water is 200-ft deep, a solution other than just traditional clam shelling was selected. Javalier Marine was contracted to relocate the overburden from the bottom of the lake using a Toyo pump and transport the material through a closed pipe system to another area adjacent to the proposed alignment. Once the overburden was removed with the Toyo pump, Walsh finished removal of the more cohesive and firm clay lining the lake bottom with a clam shell (See Photo 9). A final pass with the Toyo dredge pump was completed to ensure the rock bottom was fully exposed. This was then preliminarily verified using a weighted sounding tape.

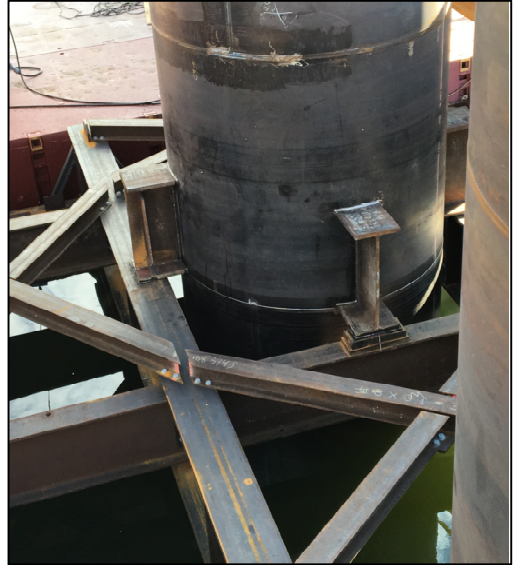
Photo 11 - Lower Lift of Casing Connected to Lowering Tray

Working from the bottom of the casing up, the lowest level of the permanent casing was modified to include high capacity support brackets. The support brackets would be designed to carry the full 1900-kip design load of the constructed foundation unit and rested on a sacrificial underwater lowering frame (See Photo 11). Note that this total design load included an incremental lowering study taking into account

Once the lowering system was assembled, the first lift of 4ea 68-ft x 102" ID x 1.5" wall casing was installed in the lowering tray. The casings were supported by W40 beam sections (See Photo 11) welded 20-ft above the bottom of the casing and welded to the frame. The first lift of casings was then lowered approximately 40-ft to facilitate the construction of the first intermediate brace (See Photo 12).

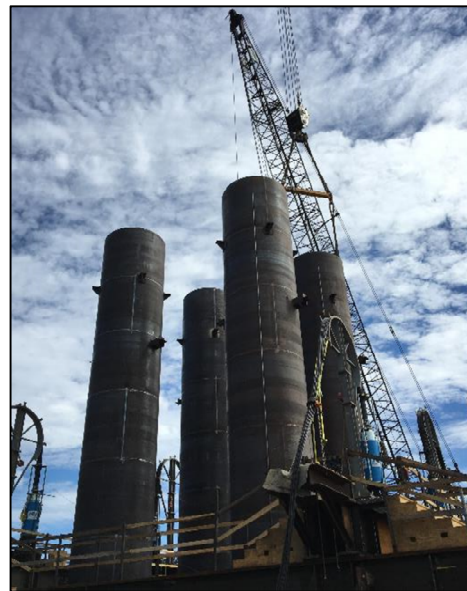
Photo 12 - First Lift of Casing Installed, Ready to Lower

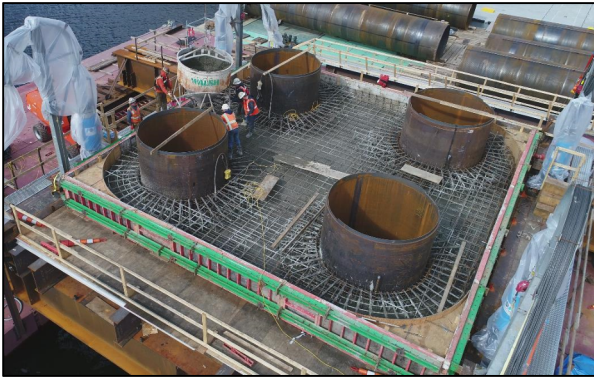
Photo 13 - Intermediate Concrete Brace Pour

Upon receipt of bid documents, one of the first questions asked by the team was "How in the heck do they think we're going to install a 3'-4" CIP brace 120-ft under water?". This ultimately led to the decision to develop a method to cast these braces above water and then lower. A soffit consisting of plywood and aluma beams was designed to be supported by W36's spanning across the main 6-ft plate girder support beams. Nelson studs were shot

onto the casing, rebar and forms installed, concrete placed (See Photo 13), next lift of casing spliced, and finally the system raised approximately 6-ft to allow workers to strip the plywood/aluma beams from under the brace. The W36 support beams were then slid out utilizing Hillman rollers temporarily attached to the casings. The entire system was then lowered approximately 60-ft and this process was repeated for the remaining two braces.

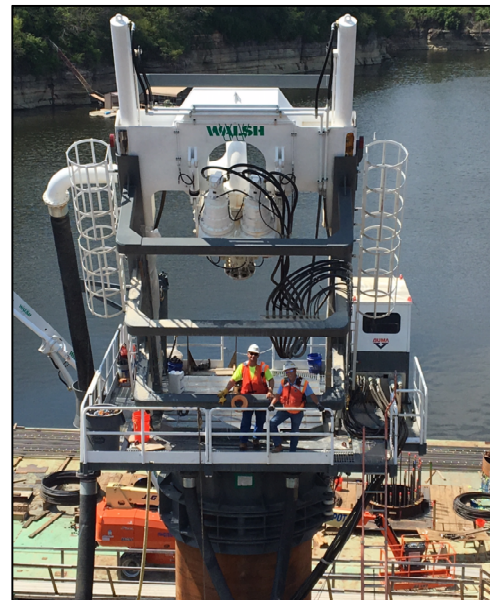
Photo 14 - Buma RCD Ready to Insert Drill String

During the bid process, it was decided to employ a reverse circulation drill system. The size of the floating platform required to support a pile top rig with 220-ft of drill string would not be feasible. Early discussions with Roc Equipment led the team to select a Buma RCD R3030 to drill the 8-ft x 37.5-ft rock sockets required for this pier.

Fluctuating lake levels during drilling operations forced to team to extend the permanent casings by up to 50-ft to ensure the floating equipment below would not bind up on the drilling platform. When the first shaft was tipped out, the measurement from the drill platform to the tip was 274-ft, an incredible feat for all involved.

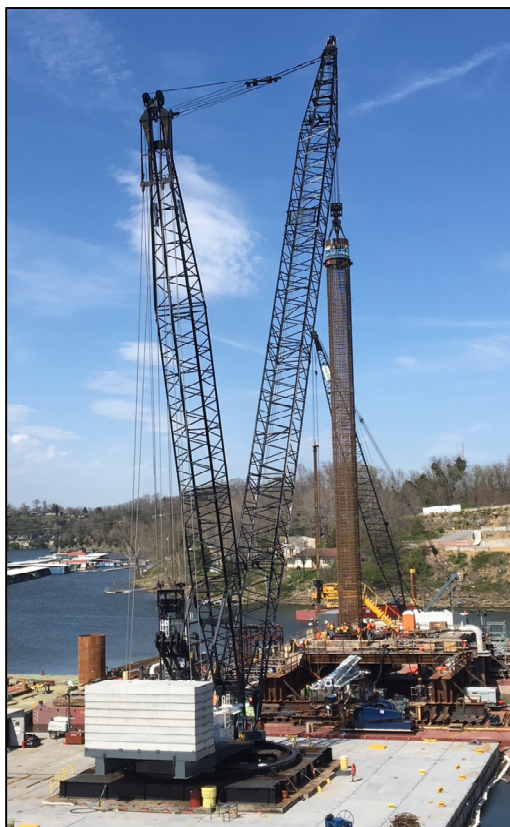
Photo 15 - 4100 Ringer Setting Rebar Cage

Rebar cages for these long shafts were initially planned to be tied horizontally in two pieces, tripped into vertical position using two cranes, then spliced over the hole. During work plan development meetings, Walsh's installer proposed tying the cages vertically and suspending from the barge until

installation. The splice over the hole would still be necessary due to the length of the cages surpassing the available headroom of the crane. Having a body of water with depths approaching 200-ft facilitated this plan and allowed all temporary crush rings and a second support crane to be eliminated from the operation. Upon installation of the cage, concrete was placed via tremie pipe.
