Replacement of the BNSF Truss 66.4 – A Multi-Level Approach to Accelerated Bridge Construction - Fabrication to Roll-On to Float-In

ALAN BLOOMQUIST, BNSF Railway, Kansas City, MO and KYLE IZATT, Advanced American Construction, Portland, OR and JOE KNAPP, Genesis Structures, Kansas City, MO

IBC 21-23

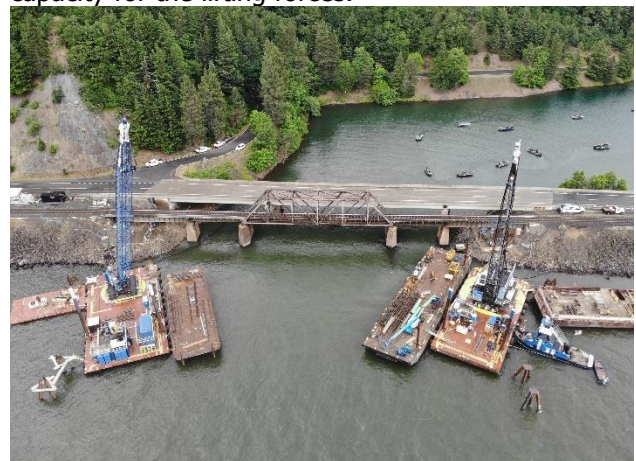
Figure 2 - Bridge Site

The existing bridge was built circa 1900 and received numerous retrofits and upgrades thru its life span. The bridge sat upon large abutment style gravity retaining walls that were retrofitted to support approach DPG spans on either side.

The truss was constructed with common riveted structural elements with eye bars and pins for the lower cord elements. The truss was evaluated for being lifted from the first two lower panel points (L1 and L2) and it was found that no significant reinforcing was required on the existing members. The first two bays of the bottom chord was made with double channels laced together which afforded some amount of compression capacity which was needed when the truss was lifted due to the cantilevered bay on each end. The vertical members of the truss, including the first hangers, were also built with laced elements that provided adequate compression capacity for the lifting forces.

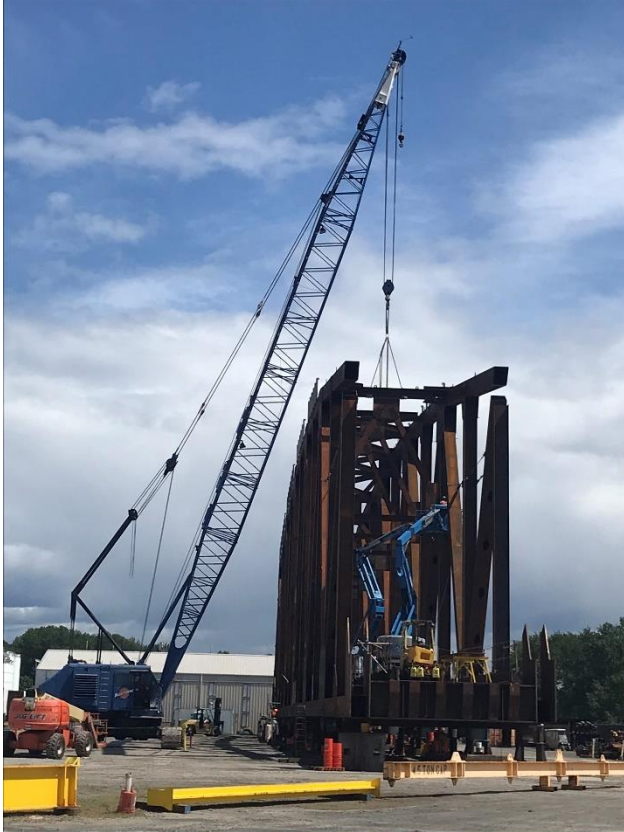
Figure 3 - Truss Assembly

The new truss was fabricated and assembled by Vigor Industrial LLC at their river front facility located in Vancouver, Washington. The truss was built in large units inside the fabrication facility and then brought outside with self-propelled motorized transports (SPMT) and assembled adjacent to the Columbia River.

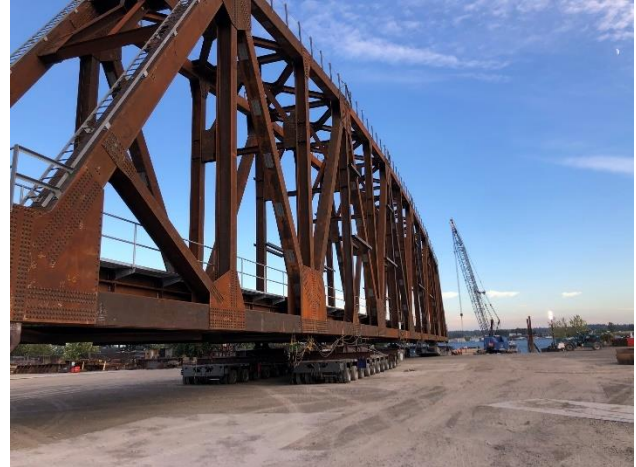
Figure 4 - Truss Roll On

After the truss was assembled at the Vigor fabrication facility, the truss was hoisted by 4-10 axle SPMTs and walked approximately 1/4 mile to a loading dock. The truss was then loaded onto a 315ftx58ftx18ft deck barge. A detailed roll on plan was required that accounted for the changes in river elevation due to tidal effects, the ballasting of the barge tanks to help keep the barge as level as possible and to control the slope of the ramp from the dock to the barge. Four 2000 gpm pumps were used to move approximately 800,000 gals of ballast water during the roll on; pumping water into the tanks as the first set of SPMTs rolled onto the barge, removing that water as the SPMT reached midship, and then pumping water back onboard as the second set of SPMTs rolled onto the barge. The total roll on took approximately 3.5 hrs to complete.

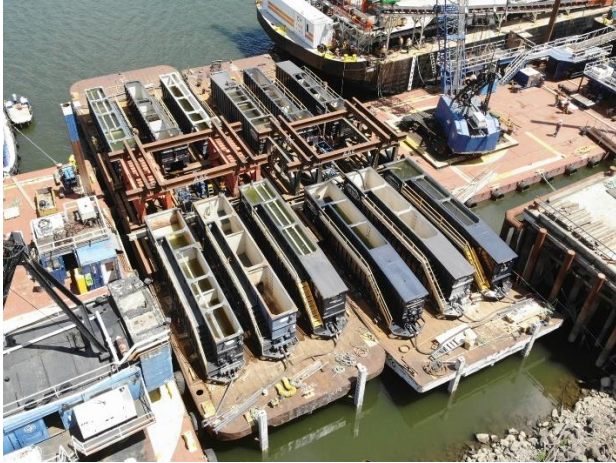
Figure 5- Removal Barges

The float out barge system was made of two 150ft x 40ft x 10ft flat deck material barges. A steel grillage system was built on top of the barge to distribute the weight of the hoisted truss to the barge and to create elevated bearing points to lift the existing truss at elevation. To provide the vertical lift necessary to lift the 700kip truss, a total of 12 open top 21,000 gallon capacity tanker trailers, also known as Baker Tanks, were placed on the barges and then filled with a total of 1.8 million lbs of water. This ballast, once released from the tanks, provided enough lift to take the weight of the truss plus raise the truss approximately 1.5 ft.

The grillage structure and Baker tanks were shimmed at strategic locations on the deck of the barge. Inside the barge, these areas were also shimmed to the barge structural elements to eliminate local crushing or failures within the barge.

This same float-out system was previously used for the float-out of BNSF Br 58.8 in 2019 located just 10 miles west of Br 66.4. The addition of upper grillage beams allowed the two barges to be lashed together and still reach out to support L1 & L2 panel points.

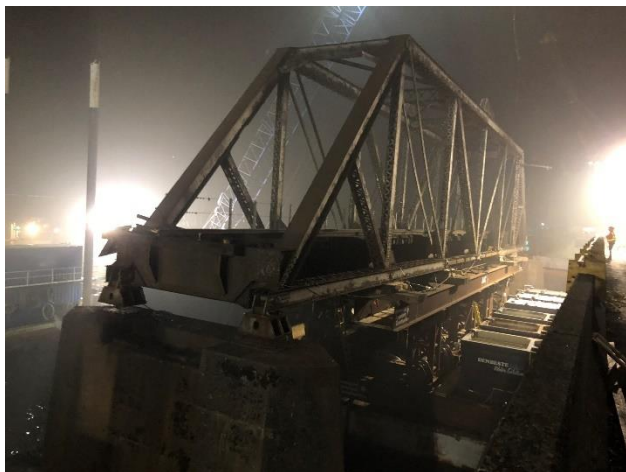
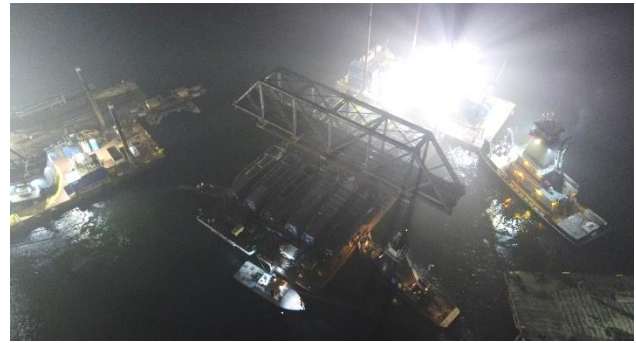
Figure 8 - Existing Truss Removal

Figure 9 - Existing Truss Removal

Once the track closure period began, the rails were cut. Ballast water was then released from the tanks on the float-out barge, tracking water levels in each tank to provide even lift on the truss. In approximately 1 hour, the existing bridge was lifted from its bearings and the float-out barge with the truss was moved aside and stored temporarily. Once the truss was removed, the two DPG approach spans were removed; one by a crane behind the West abutment and the other by a barge mounted crane.

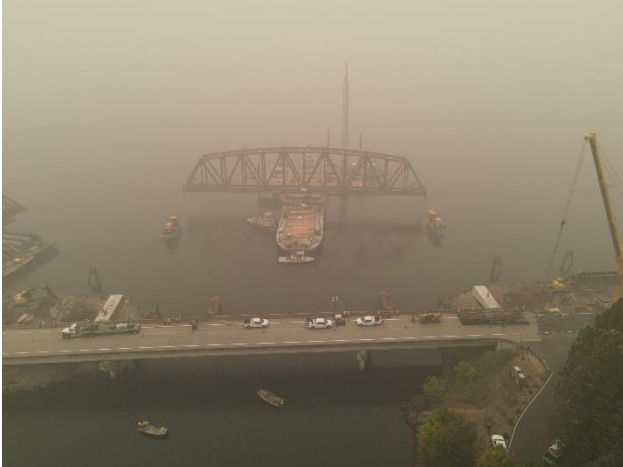
Figure 10 - New Truss Float In

Figure 11 - New Truss Float In

With the float out barge now out away from the bridge envelope, the float in barge could be positioned for the float in. Multiple spud barges were joined to the float in barge and then the flotilla was positioned south of the bridge location but in alignment for pushing into the envelope.

The flotilla was pushed northward, using the spud barges as needed to help control movement and position. Because of the narrow opening between the existing piers, the spud barges could not be advanced all the way forward with the float in barge. They remained on the South side of the bridge while the tugs continued to push the float in barge northward, using the spud barges as guides and leverage. As the float in barge bow extended under the highway bridge, winch lines were run port and starboard to help control the position of the bow.

The float in barge was advanced until the truss bearings were within a few feet of final station and offset and come-a-longs were connected at the piers to help with the small adjustments to gain final position. Ballast was then added to the float in barge until we touched down on the bearings. Ballast was continued to be added to unload the barge of the truss weight and the cribbing stacks were partially removed and the float in barge was removed from the bridge envelope.

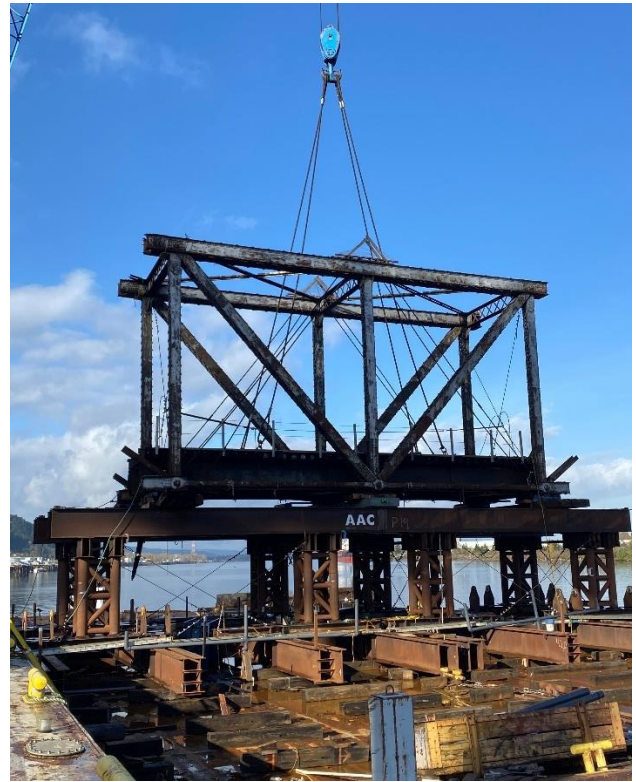
Figure 12 - Existing Truss Demolition

After the track closure was complete, the truss end segments from L0 back to L2 were removed along with a portion of the upper grillage that extended beyond the width of the float out barges. Once completed the remaining portion of the truss was lashed down and the system was sent back towards Portland and delivered to a river based recycling center for processing.
