Demolition Challenges of the Harry W Nice/Thomas "Mac" Middleton Bridge

NIKKOLAS EDGMOND, PhD, EIT, Genesis Structures Inc., Kansas City, MO
BRIAN CLARK, United Demolition, Charleston, SC

IBC 24-78

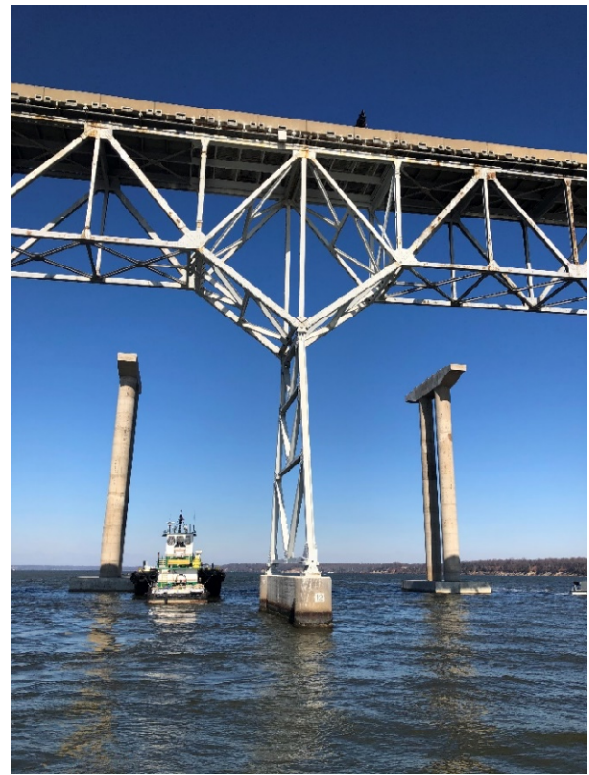
Figure 2 - View of 2D Plane Pier and Rhomboid Region

ORIGINAL BRIDGE CONSTRUCTION –
Construction of the Potomac River Bridge began in mid-1939 and was completed in late-1940, a total construction duration of approximately 18 months. This is impressive considering the structural complexity of the bridge. Pinned 2D plane frames (as shown in Figure 2) were used as the primary substructure elements for the bridge along with fixed towers (as shown in Figure 3) at discrete locations within each structural system. Additionally, unique rhomboidal regions at the pier locations required a strict erection plan to maintain structural stability. Similar design considerations were critical for the demolition.

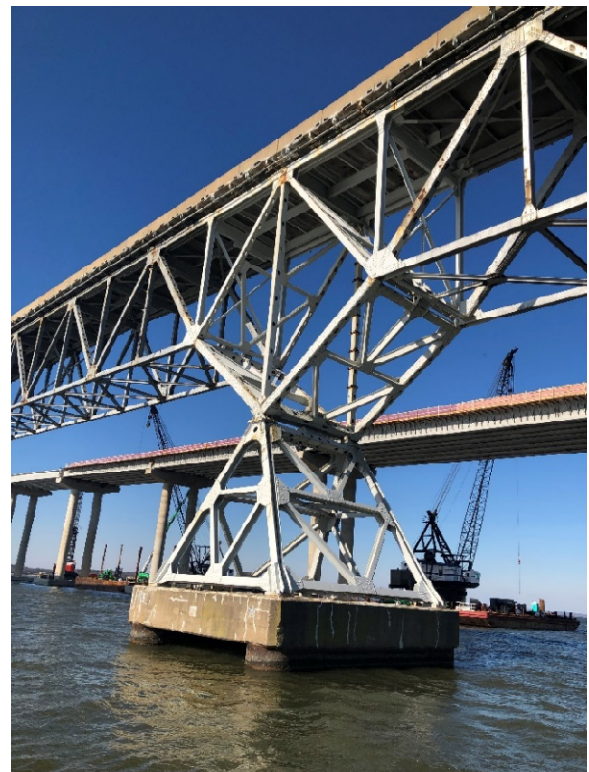
Figure 3 - View of Fixed Pier Tower

The suspended span was supported by two fixed tower piers and adjacent anchor spans. The original construction employed an elaborate network of temporary frames, struts, and cable supports to provide stability of the truss prior to erection of the suspended and anchor spans as shown in Figure 4.

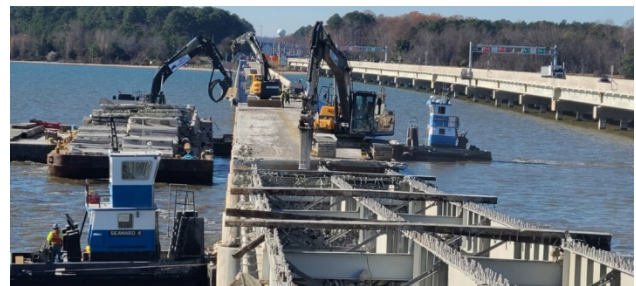
Figure 8 - Trestle Span Demolition

Figure 8 shows the in-field demolition operations for the trestle span. As engineered and detailed, a series of excavators positioned on the deck removed deck sections while excavators positioned on a barge removed steel superstructure once the deck was entirely removed from a span.

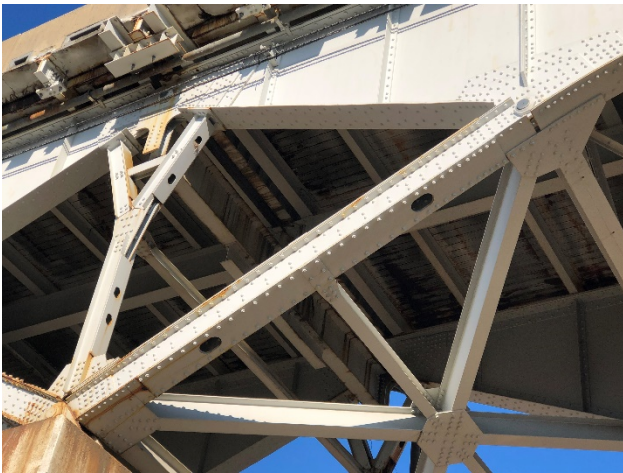
Figure 10 - Girder Span Pier Framing

6-span continuous system. At each pier location, the girders framed into the top of the substructure through diagonal struts and posts while containing a hinge at the top of the girder to allow for rotation. Figure 10 illustrates the structural layout of the girders at the pier locations. These regions are referenced as the rhomboid regions due to the unique rhomboidal shape created by the change in girder depth and framing struts. The vertical posts seen in Figure 10 were not part of the original design and were added during the rehabilitation work in 1985.

Multiple demolition methods and sequences were evaluated to meet the needs of the contractor, however, the main challenge for all scenarios for the girder spans was the load effects at the rhomboid regions. The installation procedure for the vertical posts during the 1985 rehabilitation work induced minimal dead load into the post members. The majority of the loading is from the application of live loads on the structure. Therefore, any imbalance of dead load from the adjacent spans induced tension in the vertical posts. Unfortunately, the connection details of the vertical posts were not adequate for this loading, and therefore, the deck demolition required a unique sequence to minimize the tensile loading in the vertical posts.

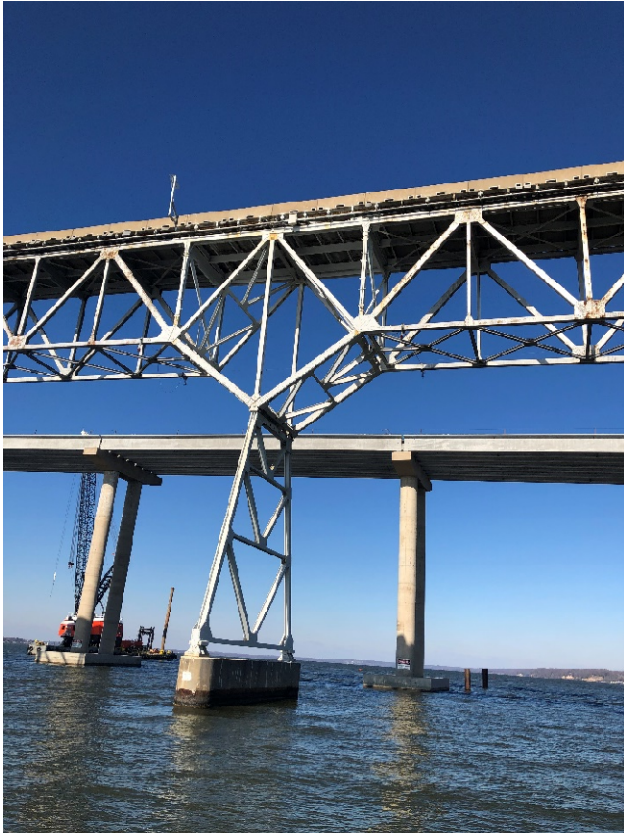
Figure 15 – Deck Truss Span Pier Framing

The stringers were continuous over the floorbeams and the trusses were continuous over the piers in a 3- or 4-span configuration. Similar to the girder spans, the deck trusses framed into the top of the substructure through diagonal struts and posts, while containing a hinge at the top of the truss to allow for rotation. Figure 15 illustrates the structural layout of the trusses at the pier locations.

Multiple demolition methods and sequences were evaluated to meet the needs of the contractor, however, for all scenarios the rhomboid regions once again proved to be the primary challenge. Differences in detailing of the rhomboid region of the deck trusses compared to those in the girder spans, meant that tension

on the deck truss posts was not an issue, and therefore, a unique deck panel removal sequence was not required.

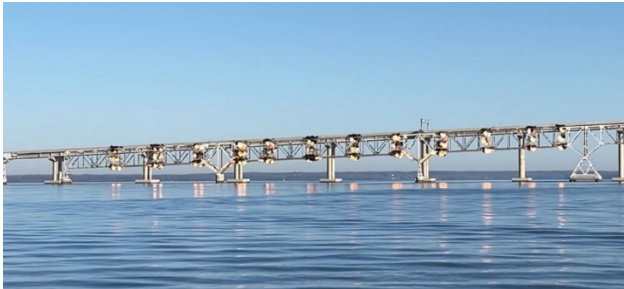
Figure 17 - Deck Truss Explosive Demolition

The steel truss removal was completed using explosive demolition (See Figure 17). The explosive charge locations were selected such that the individual truss segments would not exceed 100 tons when hoisted out of the river, as well as ensuring that each segment would be stable during hoisting.

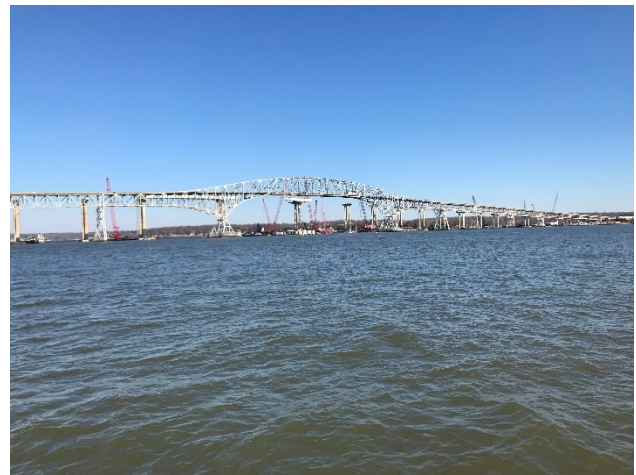
Figure 1 - Main Suspended Span and Anchor Spans

The global structural system was comprised of 367 ft. anchor spans which supported the 400 ft. suspended span off of 200' cantilever arms (See Figure 19). The suspended span weighed approximately 1,400,000 lbs.

The primary challenge for the demolition of these spans was the imbalance of load between the suspended span and the anchor spans. If the deck was completely removed from the anchor spans prior to the suspended span, the end piers would experience large uplift forces.
