Sequenced Removal of the Non-Redundant I-30 Bridge

STEVE EADS, Genesis Structures Inc., Kansas City, MO and JAMES CASTER and LOGAN MCINVALLE, Kiewit Massman Construction, Little Rock, AR

IBC-24-80

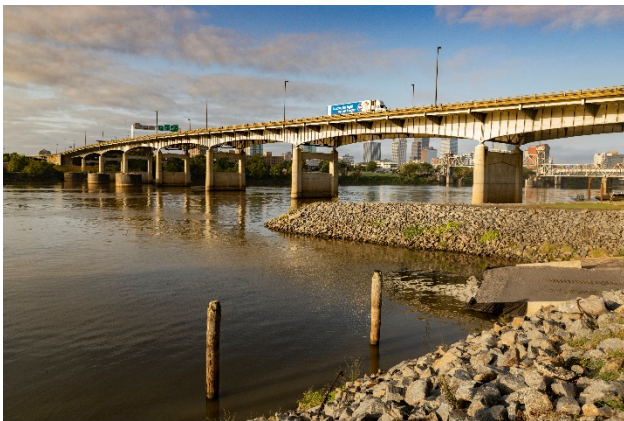
Figure 1 - Original Bridge

The I-30 Bridge connects Little Rock and North Little Rock and spans the Arkansas River in Pulaski County, Arkansas. The bridge is a critical link between the adjacent communities. The original bridge prior to replacement can be seen in Figure 1.

The original I-30 Bridge was constructed in the late 1950s. The main river crossing was highlighted by eight spans with span lengths ranging from 160' to 210'. The main spans superstructure consisted of a reinforced concrete deck supported by steel stringers

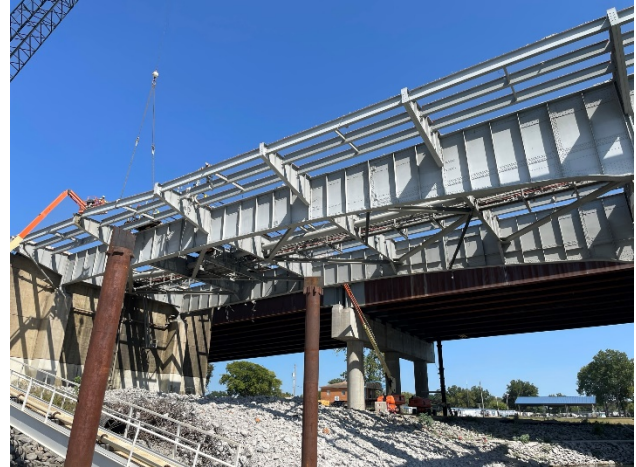
Figure 3 - Structural Components

The two excavators hammering on the deck during deck removal is a non-typical bridge loading. The effects of the deck removal operation were considered for all structural bridge components. The typical structural elements considered in the evaluation are visible in Figure 3. In this photo the deck has already been removed.

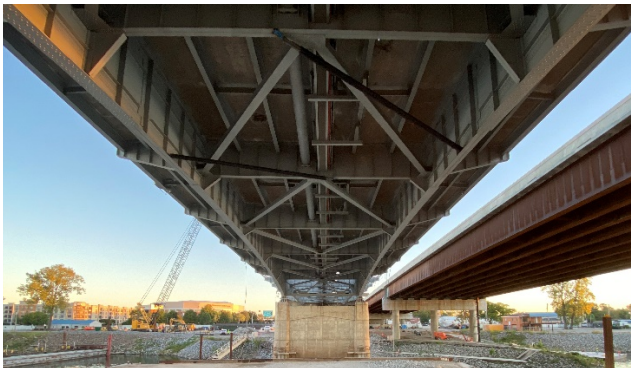
Figure 6 - Pipe Brace

During deck removal, there were multiple girder locations identified that required additional strength to overcome the bending demands. The six identified locations were all located in negative moment regions, where the bottom flange was in compression. There were multiple options considered to improve the evaluation, but ultimately it was decided to install a bottom flange brace (as visible in Figure 6) at these locations to reduce the unbraced length of the compression flange and increase the girder lateral torsional buckling capacity.

To act effectively by preventing the lateral displacement of the compression flange, the girder flange brace was required to resist 2% of the compressive force in the flange. It was conservatively assumed that the flange demand was equivalent to the max allowable demand in the flange. As mentioned above, the girder flange that required a brace did not have any cover plates and only consisted of 2 flange angles.

A Dayton Superior pipe brace with 25,000 lb capacity was selected as the flange brace. The brace was welded between a floorbeam bottom flange and the girder bottom flange (at midspan between floorbeams). This effectively cut the girder unbraced length in half, which provided the lateral torsional

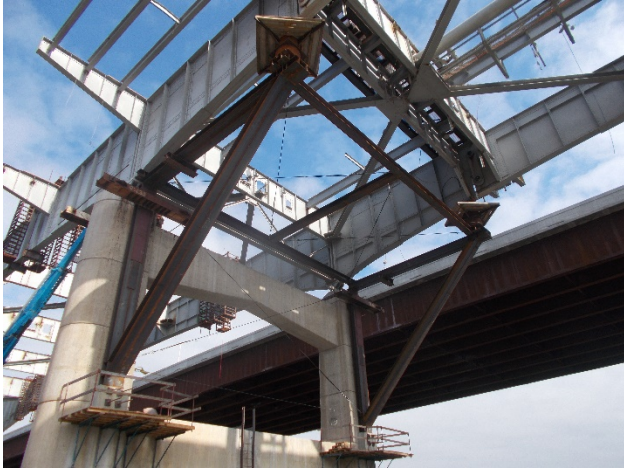
Figure 7 - Pier Bracket

PIER BRACKET - As portions of the bridge were cut and removed, temporary support was required for stability of the remaining structure during intermediate stages of the demolition. Temporary support was provided with a pier bracket affixed to the existing piers as seen in Figure 7.

The service level design reaction at the pier bracket was established as 200 kip per side / girder.

Primary Members – The main frame structural components of the pier bracket frame consisted of a top horizontal member, a vertical member (adjacent to the existing pier), and a diagonal member. Each of these main frame members were composed of two HP14x73 Grade 50 beams welded together along the full length of the top and bottom flange. As can be seen in Figure 7, a pier bracket frame was positioned directly below each girder.

When the pier bracket was engaged, the weight of the supported superstructure segment above was transferred through the pier bracket to the existing pier. This load transfer resulted in a tension demand in the top horizontal member, a bending and shear demand applied to the vertical member, and compression in the diagonal member.

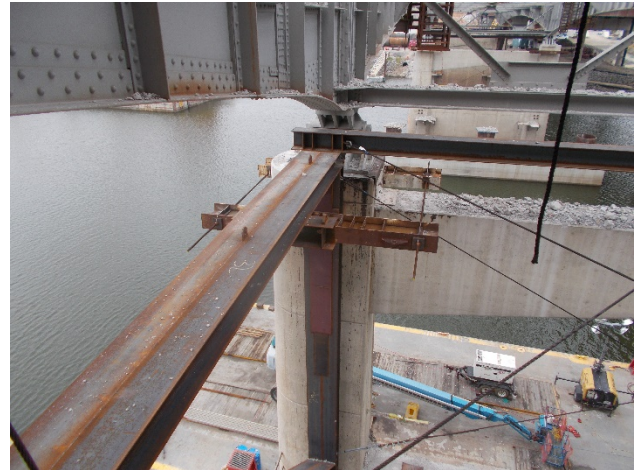
Figure 8 - PT Beam

existing pier. This clamping force was provided through use of 1¼" diameter 150 ksi threaded bars post-tensioned (PT) to 130 kip each and W24x117 beams as can be seen in Figure 8. A clamping force was provided to ensure that when the maximum load was applied, the vertical member would stay securely in contact with the existing pier.

If the pier bracket upper support reaction was provided in line with the top horizontal member, the vertical member shear and bending demand would have been eliminated. But the relation of the pier bracket to the top of the existing pier resulted in a support location that was positioned 4' below the top horizontal member. The resulting flexural demand on the vertical member necessitated the addition of cover plates near this point of support to increase the flexural capacity.

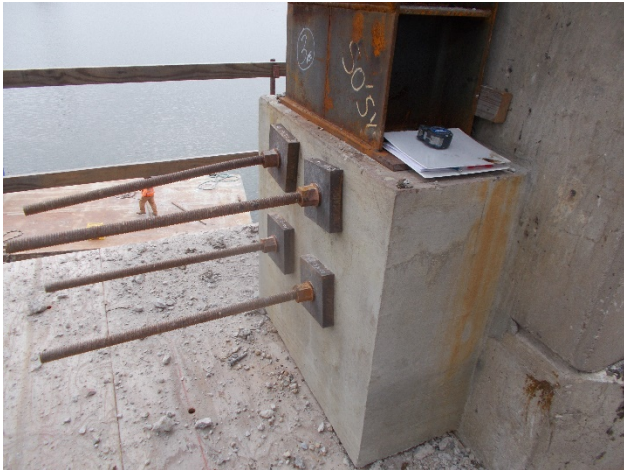
Figure 9 - Corbel

Corbel - The corbel was a cast-in-place concrete pedestal on the face of an existing pier that provided the vertical support for the pier bracket self-weight and applied reaction from the superstructure above. The corbel also provided resistance for all lateral wind loads acting on the supported girder. The corbel can be seen in Figure 9.

To support the self-weight of the corbel during casting, rebar was attached to the face of the existing pier with drill and epoxy methods. Specifically, Hilti HIT-RE 500 V3 adhesive was used to bond the #5 Grade 60 mild reinforcing for temporary support of the corbel. Once the corbel concrete had cured and was being considered for support of the vertical loads from the pier bracket, this mild reinforcing was neglected. It was determined that a much more

Multiple options were considered, but ultimately a system of post-tensioned bars acting on the corbel served as the primary means of resistance for the bracket reaction. There were 4 - 1 1/4" diameter 150 ksi threaded bars stressed to 150 kip each. 1 3/4" diameter holes were drilled through the full width of the existing pier. A nut and base plate were provided on the back side of the pier to anchor the high strength bar. This effectively eliminated the concrete breakout failure limit state that proved to be an issue when partial depth reinforcing & epoxy options were considered.

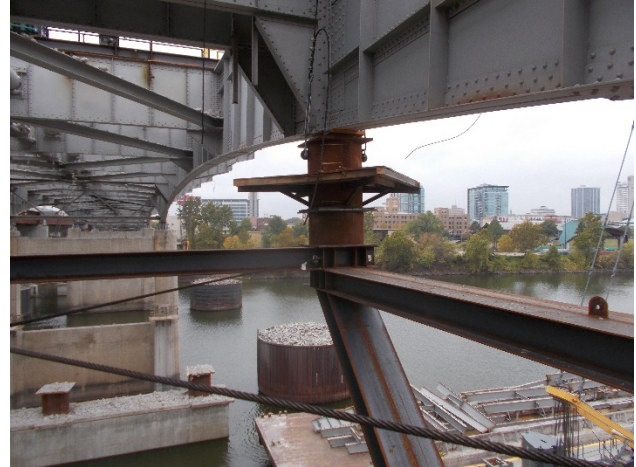
Figure 10 - Pipe Stand

Pipe Stands - The elevation difference at the point of support between the top of the pier bracket and the bottom of the girder was accounted for with the introduction of a pipe stand as seen in Figure 10. This pipe stand was required to resist the vertical and lateral demand acting on the pier bracket.

Pipe stands were designed to support the jack stands at the end of the pier brackets. The pipe stands were affixed to the top of the pier bracket and varied in height according to pier location. A typical connection detail at the top of the pipe included a cap plate with cruciform shaped stiffener section below that could be inserted into the top of the pipe stand.

Apart from the height of the pipe stands, a typical design was used for the pipe cross-section, cap plate, and the cruciform shaped stiffener. Demand to the pipe stand was evaluated for the maximum gravity and lateral loading at the pier brackets.

A LUSAS finite element model was used to evaluate stresses in the pipe stand elements. The pipe and associated plates were modeled as shell elements. The cap plate and stiffeners are designed with grade 50 steel and the pipe was assumed to be a minimum of grade 36.

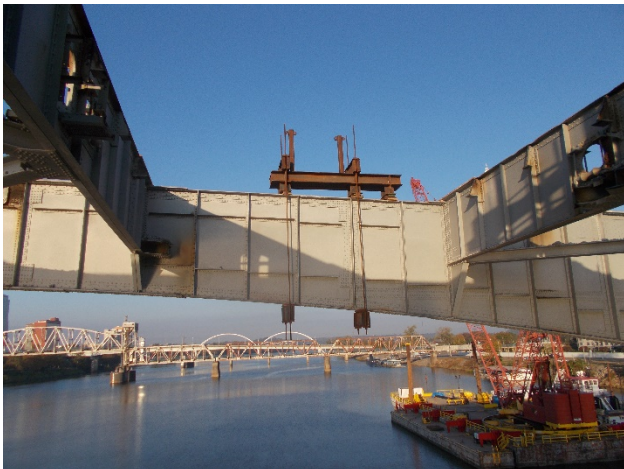
Figure 11 - Strong Back

STRONG BACK - After the required pier brackets were securely in place, a midspan segment could then be prepped for removal. The strong back system was installed at each end of a midspan girder segment to allow for a complete section cut of the girder prior to crane support. This allowed for the timely girder cutting process to occur without support of the crane. The strongback system can be seen in Figure 11.

At each girder end, the system consisted of double strongback beams (2-HP14x89) and a hanger system to support the span segments being cut. The hanger system consisted of an upper and lower double channel assembly to receive the 1 1/4" diameter 150 ksi threaded bars. At the front location, the bars were stressed to 100 kip each, thus 200 kip total. The rear location does not see any tensile load, thus bars were

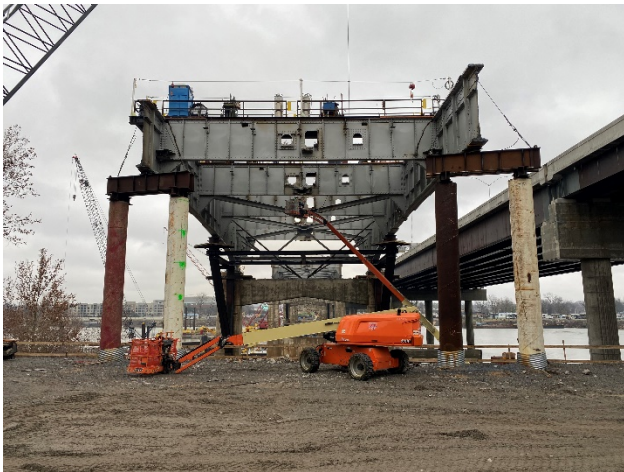
Figure 13 - Falsework Towers

A pair of isolated falsework towers were used to support the girders near midspan during demolition. The falsework tower at each girder consisted of a header beam (Double W24x117) below each girder spanning between two piles (36" diameter with 1/2" wall thickness). Figure 13 shows the falsework towers in use following the removal of the Pick 18 (ref Figure 12).

The falsework tower location was immediately adjacent to a proposed location for a retaining wall. In fact, it was the retaining wall that forced the unsymmetric placement of the falsework towers (visible in Figure 12). Through proper planning corrugated metal sleeves inserts were installed prior to construction of the retaining wall. The piles could

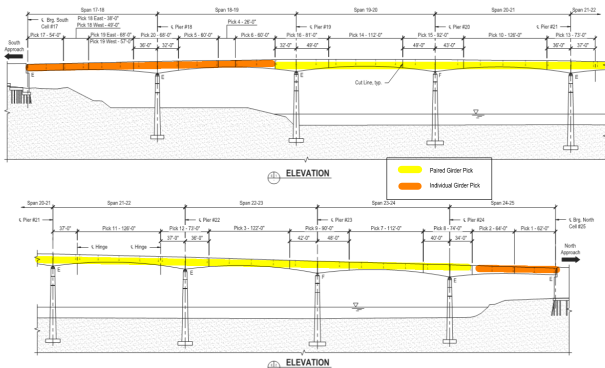
Figure 14 - Girder Pick Condition

There were 11 lifted segments or approximately 5 spans removed as paired girder picks (shown highlighted yellow in Figure 14) with the barge mounted crane. And there were 9 segments (thus 18 total individual girder picks) or approximately 3 spans removed as individual girder picks (shown highlighted orange in Figure 14) with the land-based crane.

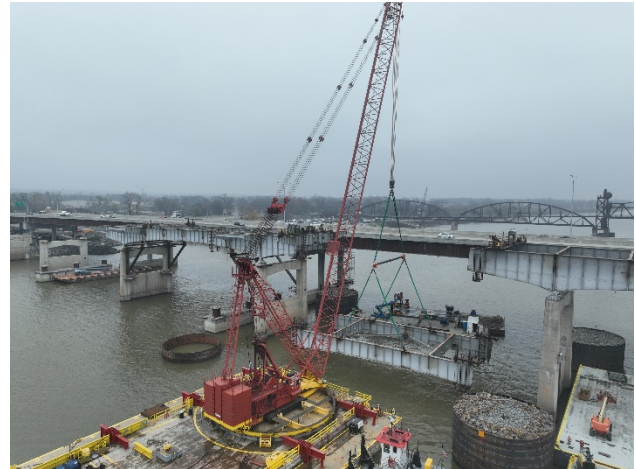
Figure 15 - Paired Girder Pick

Paired Girder Pick - The barge mounted ringer crane lifted large combined sections of the bridge. A paired girder pick included portions of both girders in addition to multiple floorbeams, lateral bracing, and stringers as shown in Figure 15.

A transverse spreader was used to ensure there was no transverse component of sling force acting on the cut girder segments. The angle of the inclined slings in the longitudinal direction was limited to 60 deg to limit the axial compression induced into the girder segments.

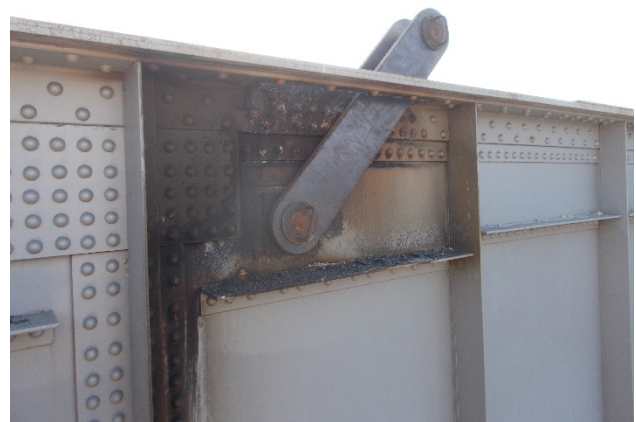
Figure 16 - Custom Lifting Lug

The paired girder picks were lifted with custom lifting lugs as visible in Figure 16. The existing girder had to be modified at the custom lug locations. The bearing capacity of the web plate was improved with the addition of cheek plates welded to each side of the web. A 4"x28" slot was also carved into the top flange on each side of the web to provide clearance for the lug plates. Large 3 1/2" diameter Grade 110 pins were used both at the interface with the web and the sling.

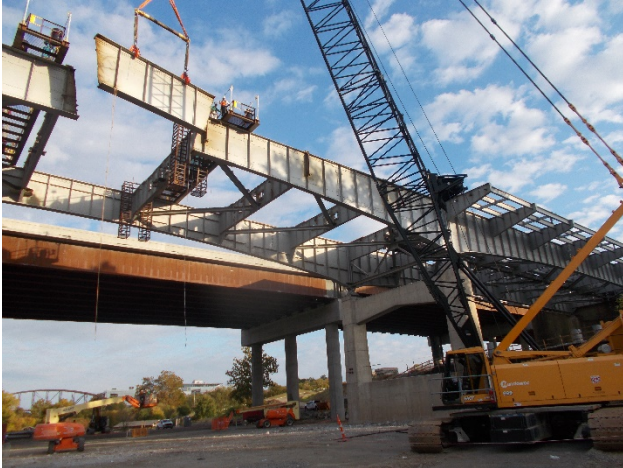
Figure 17 - Individual Girder Pick

removed by the land-based crane. The Manitowoc 999 made use of flange grabs to fully support a given girder segment prior to removal. Once fully supported by the crane, the girder segment for removal was then torch cut and lifted out of position as shown in Figure 17.

There was a total of 18 individual girder (9 segments) pick operations performed. The individual girder pick size varied from a minimum of approximately 26' long with weight of 25 kip to a maximum of 68' long with weight of 159 kip. Depending on the pick weight and geometry either a Crosby NS-35 or a custom 50 Ton flange grab option was used.

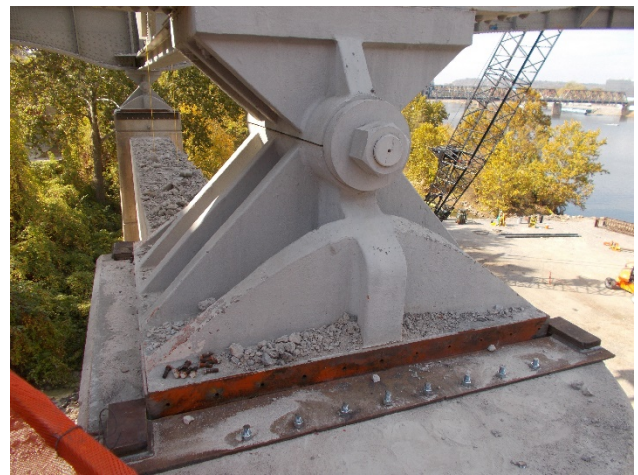
Figure 18 - Longitudinal Bearing Restraint

The longitudinal restraint was provided with installation of a bearing bumper system as seen in Figure 18. A restrainer plate was rigidly attached to the top of the pier on each side of the bearing. Each restrainer plate connection was accomplished with 8 - 3/4" diameter A36 threaded rods bonded with HILTI HIT-RE 500 V3 epoxy. At the extreme ends of the restrainer plate were bumper plates that protruded beyond the edge of the bearing and prevented any differential displacement between the bearing and the pier. In this manner, the bearing was locked into the pier and the longitudinal expansion function of the bearing was eliminated.

The longitudinal restraint system could be installed at any time, but was only engaged with shims wedged between the restrainer plate bumper system and the expansion bearing base plate. By engaging this longitudinal lock up device just prior to needing it, temperature loads could safely be ignored, and only longitudinal wind loads acting on the relevant floorbeams were considered.

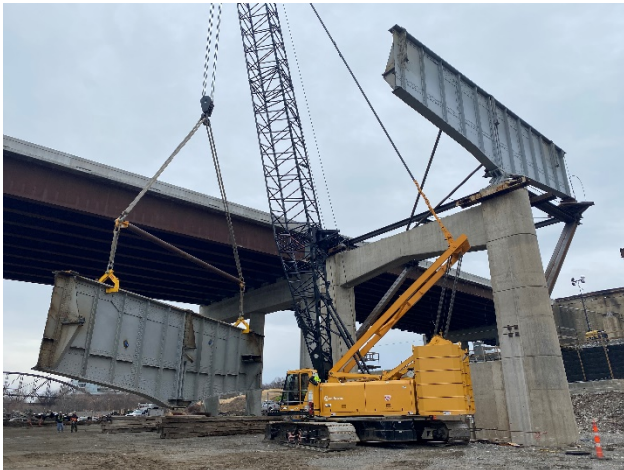
Figure 19 - Final Girder Brace

Temporary bracing was required prior to the removal of the existing floorbeam and lateral bracing. A bracing detail similar to the one used to brace girders during deck removal was used for this condition. Two Dayton Superior 33 HD Jumbo Pipe Braces were

The photo in Figure 19 shows the first of the final individual girder segments during removal. The temporary bracing providing lateral stability for the final girder segment remaining on the pier / pier bracket is visible.

The brace bottom connection plate for each of the four braces (2 per girder) was welded to a single common steel base plate that was anchored to the top transverse pier beam. The brace top connection plate was welded to the girder web. With the lateral wind pressure and defined brace geometry a brace force was determined and both connections were evaluated.

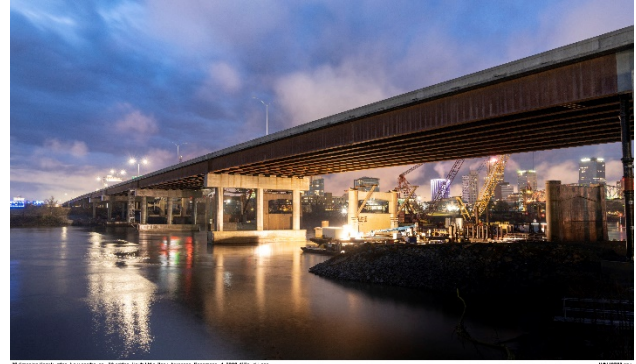
Figure 20 - New EB I-30 Bridge

Construction began on the new Eastbound I-30 Bridge in October 2020. The new bridge alignment did not conflict with the existing bridge as it was positioned east of the existing I-30 Bridge. The construction of this bridge was completed and was officially opened to traffic in September 2022. It was at this time, that both directions of traffic were switched over to this newly constructed bridge. A photo of the new bridge following removal of the

existing bridge superstructure can be seen in Figure 20.
