Sequenced Removal of the Non-Redundant I-30 Bridge

Steve Eads, Genesis Structures

IBC 24-80

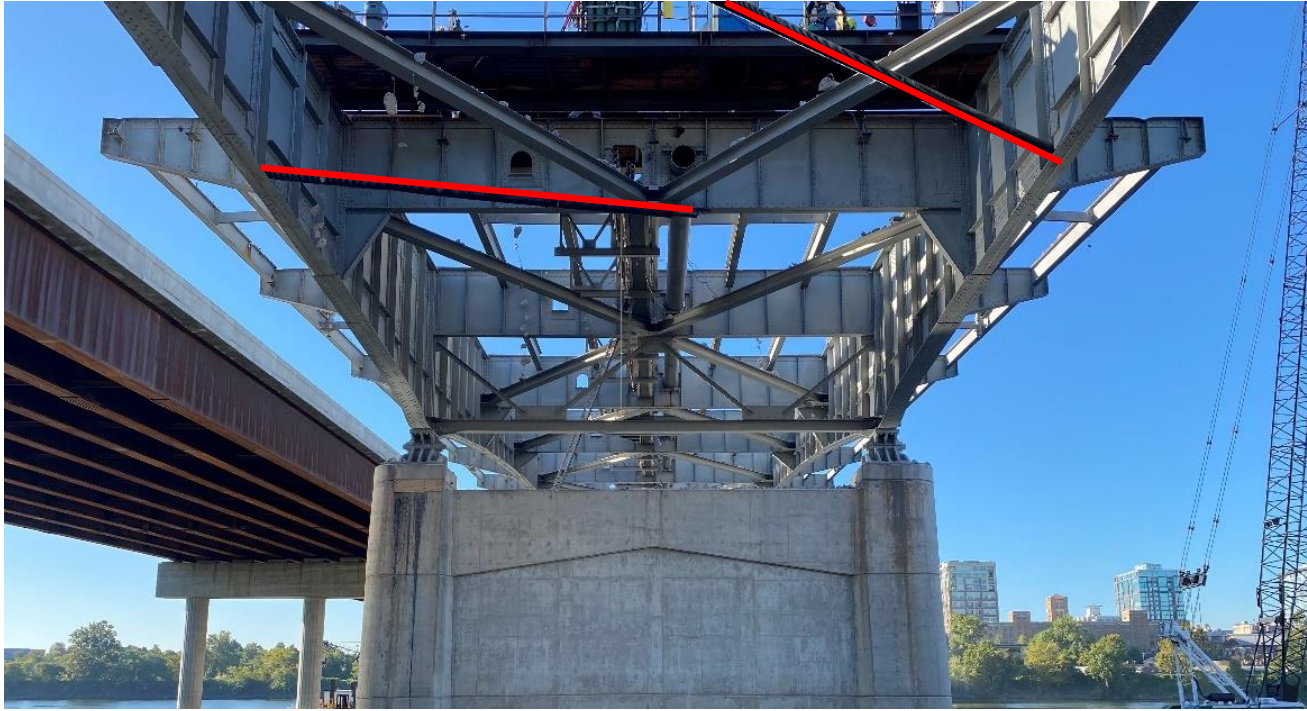
Girder LTB Bracing

- Girder near dead load contraflexure point
 - Original demand minimal
 - No flange cover plates, only flange angles
- Negative moment increase during the deck removal operation
 - Bottom flange in compression
- Opted to increase capacity as opposed to decrease demands

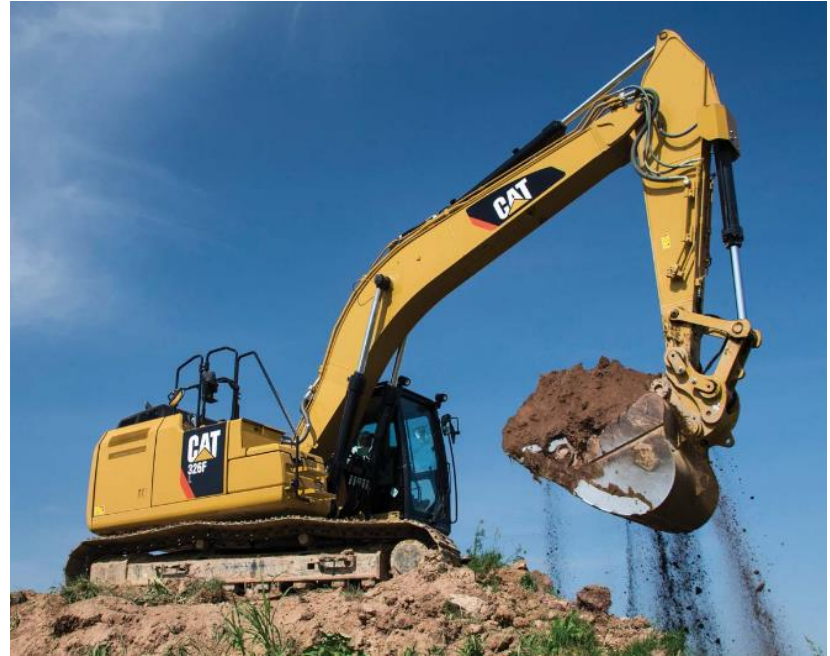
Deck Removal

CAT

326F

Hydraulic Excavator

1. Excavator Operating Weight = 58,801 lbs (including hammer)
2. Impact Hammer Attachment Weight = 3,800 lbs
3. Shearing Tool Attachment Weight = 3,800 lbs

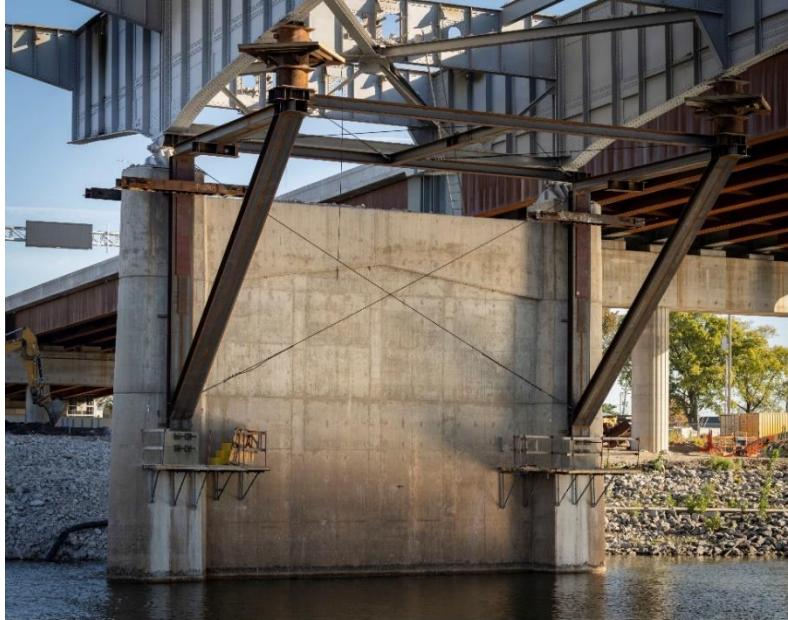
Pier Bracket

30 Crossing Construction Pier 24 with pier brackets. Demolition of I-30 bridge, North Little Rock, Arkansas, October 20, 2022. ©David Hogg

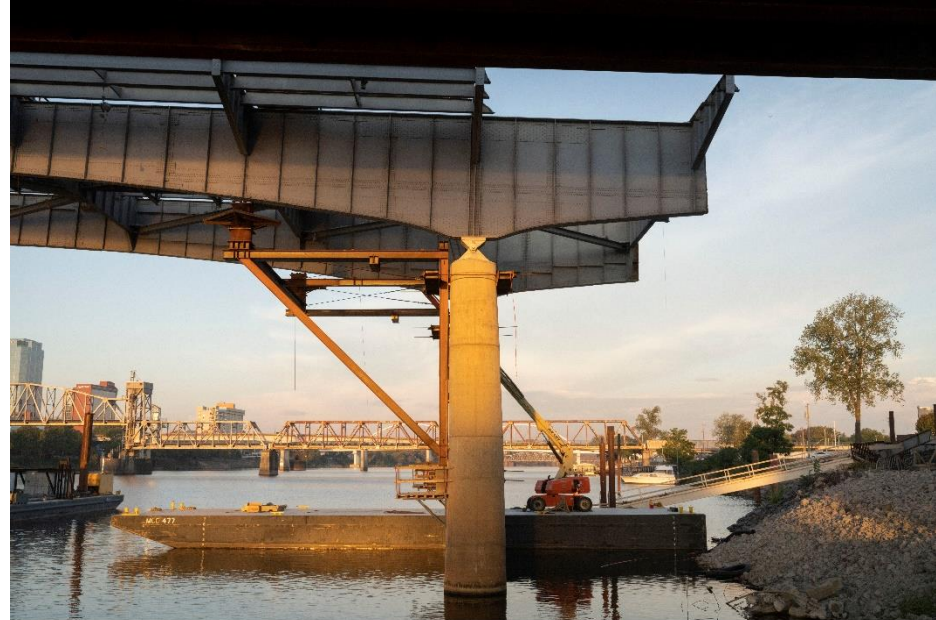
30 Crossing Construction Pier bracket on P-21. Demolition of I-30 bridge, North Little Rock, Arkansas, October 12, 2022. ©David Hogg

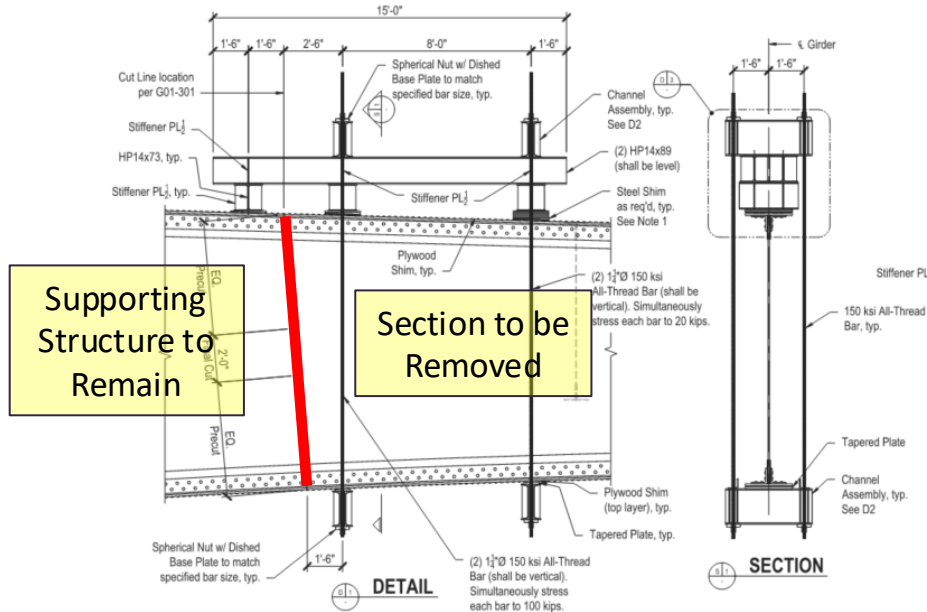
Strong Back

Supporting Structure to Remain

Section to be Removed
