# Buck O'Neil Bridge Demolition

STEVE EADS AND ZACH BARDOT, Genesis Structures Inc., Kansas City, MO and KEVIN DEYE, Massman Construction Co., Kansas City, MO

IBC 25-03

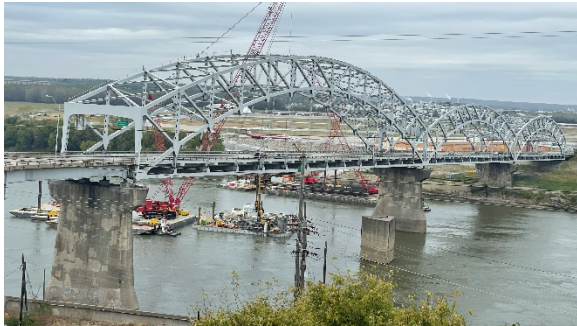
Figure 2 - Main River Span Unit 4

The furthest unit to the south (Unit 1) consisted of a non-redundant through plate girder span being braced by the cast-in-place deck. Bridge Units 2 & 3 can both be considered a more typical approach unit which consisted of continuous steel plate girders with connecting diaphragms for support of stringers. The main river spans (Unit 4) consisted of three unique signature tied arch spans with span lengths varying from 450' to 540' (see Figure 2).

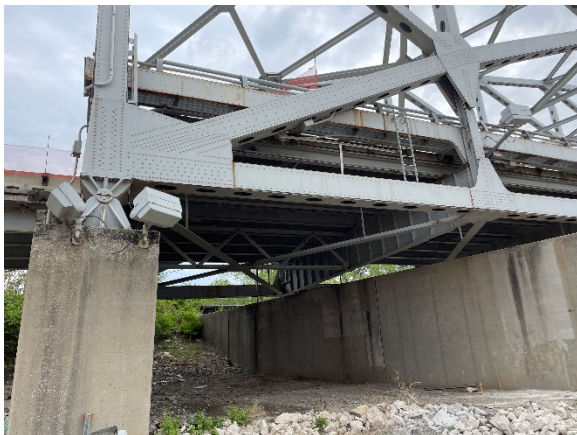
Figure 9 - North Arch

The northern end of the northern arch was positioned directly above a Corps of Engineers levee wall that runs along the north shore of the Missouri River as visible in Figure 9. This levee wall was to remain undamaged following the bridge demolition.

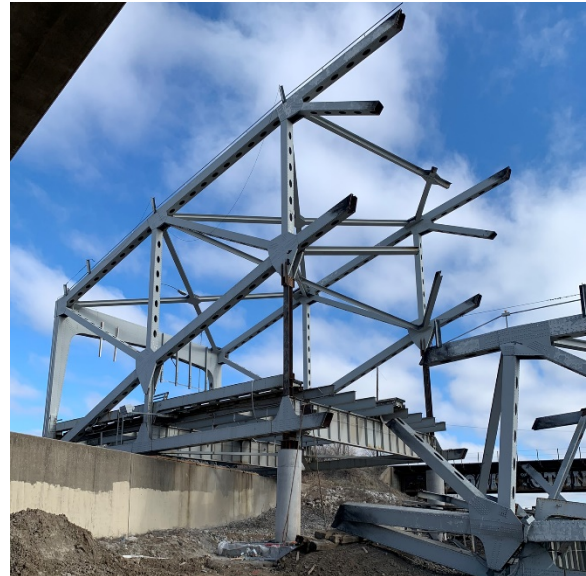
Figure 10 - Remaining Structure

the use of explosives (similar to the other two arch spans). The majority of the span (9½ panel points) was to be dropped using explosives, while the portion of the arch positioned above the levee (2½ panel points) was to remain in place following the explosive event. The instantaneous loss of a portion of the span resulted in a dynamic response for the structure to remain in place. The structure remaining following the explosive event can be seen in Figure 10.

TEMPORARY BENT – A temporary falsework tower was constructed to support the arch structure to remain following the explosive blast. As is visible in Figure 10, the temporary falsework support was positioned at the 2<sup>nd</sup> panel point from the end, plan identified as “T2”.

The maximum downward reaction of approximately 500 kip controlled the design of the reinforced concrete column and footing design. But the results of the analysis model also indicated brief moments of uplift at the temporary bent support location. A maximum tensile reaction of 30 was anticipated. XIP wire rope tie down cables were installed to resist the instantaneous tension demand to keep the arch securely positioned on the falsework. With a close examination of Figure 10 and / or Figure 11 the tie down cable system is visible.

A temporary post was custom fabricated and installed between the T2 (tie girder) and L2 (arch) panel points to provide a mechanism for load transfer between the tie girder and arch for the post blast compressive design load. With close study, the temporary post can be seen in Figure 10.

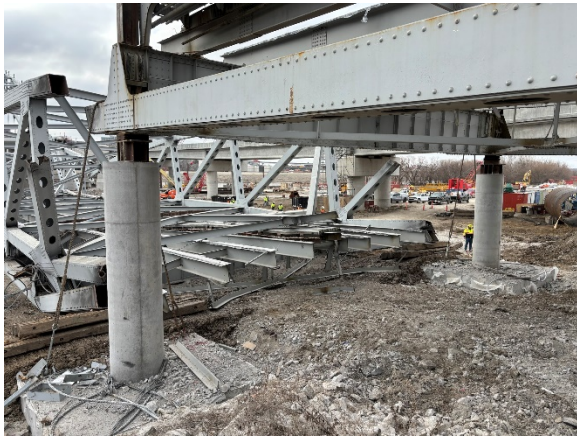
Figure 11 - Temporary Falsework Bent

Multiple options were considered, but ultimately a typical reinforced cast-in-place concrete column supported on spread footing was selected as the preferred option (see Figure 11).

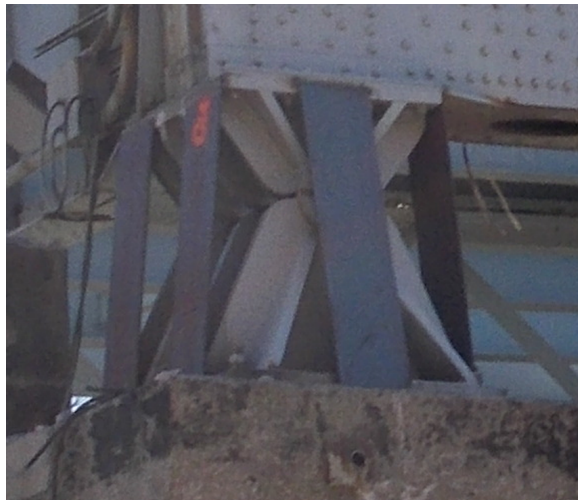
Figure 13 - Pier 4 Uplift Restraint

The dynamic model results indicated the maximum uplift reaction was approximately 260 kip. To resist the anticipated uplift, a load path was provided via an external restraint system that consisted of a series of plates that were welded directly from the top bearing casting to the bottom bearing casting. A photo of the restraint system installed at the Pier 4 bearing is provided in Figure 13.

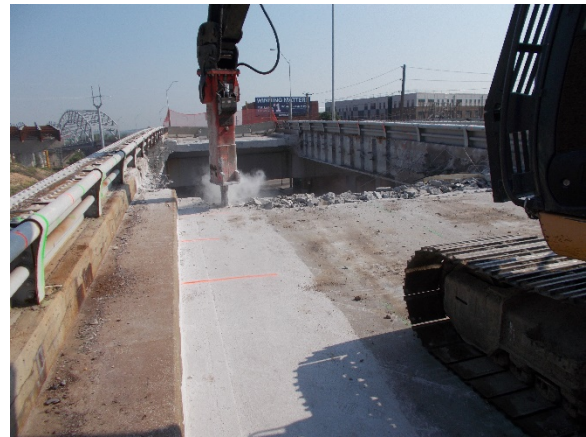
Figure 16 - Unit 1 Deck Removal

DECK EVALUATION - The deck was the structural component for transverse load distribution to the steel plate girders. The deck was required to support the excavator during the deck removal operations by spanning between the girders. A photo of the deck removal operation can be seen in Figure 16.

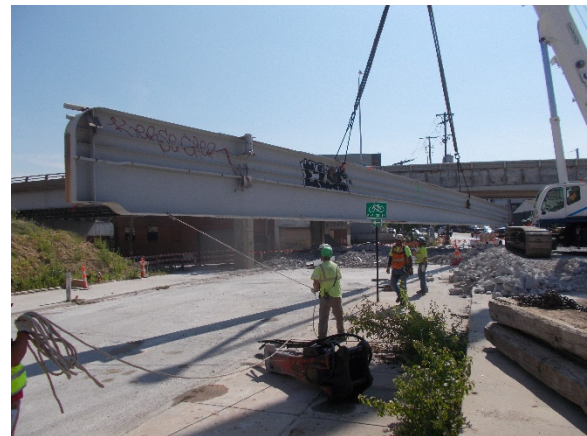
Figure 18 - Unit 1 Girder Removal

The lifted segment weight was used to determine the rigging demand and to select the appropriate hardware. An access window was cut into the girder web to allow for the rigging to girder connection. A girder lift operation can be seen in Figure 18.

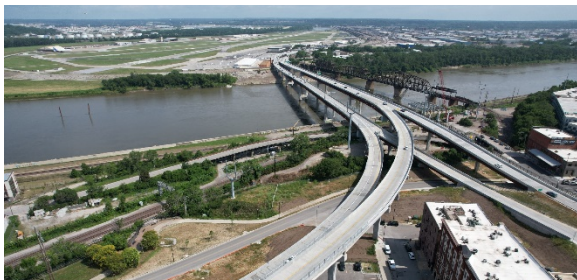
Figure 20 - Current Status

Construction of the new Buck O'Neil Bridge started in June 2021. The closure for southbound traffic started in February 2023 and ended in November of 2024. The demolition of the existing Buck O'Neil Bridge started in June of 2023. The complete demolition of the existing Buck O'Neil Bridge was successfully completed in July of 2025. A status photo showing the new bridge is provided below in Figure 20.
