# Repairs to the Historic Tombigbee River Hwy 182 Bridge

Joe Knapp, P.E. Genesis Structures, Kansas City, MO  
Steve Bowen, P.E. Malouf Construction, Greenville, MS  
Randy Boudreaux, P.E. Neel-Schaffer, Jackson, MS  
IBC 25-10

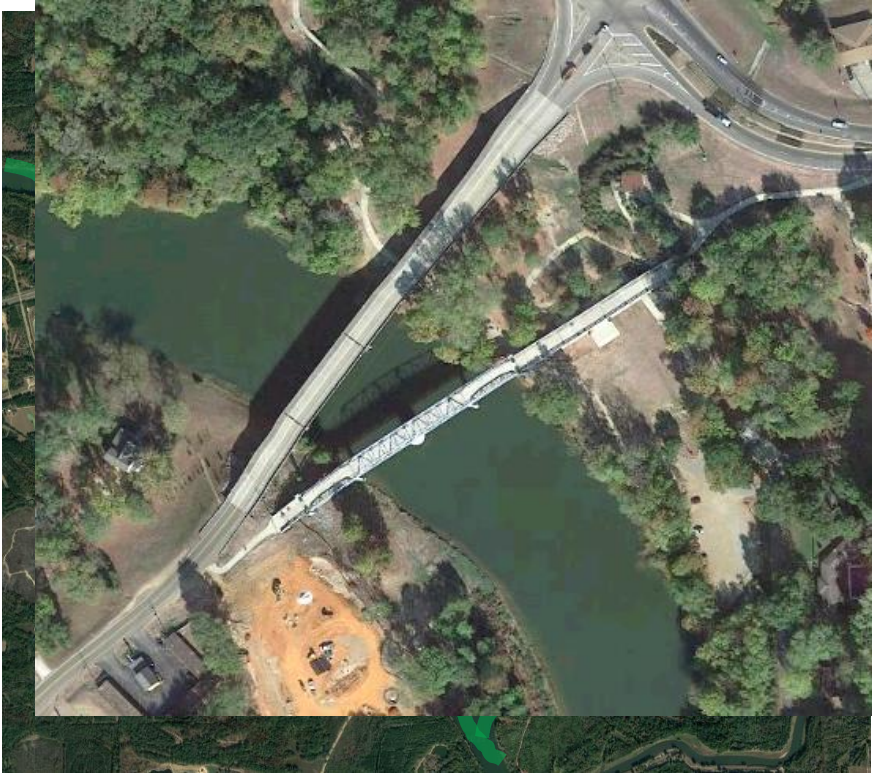
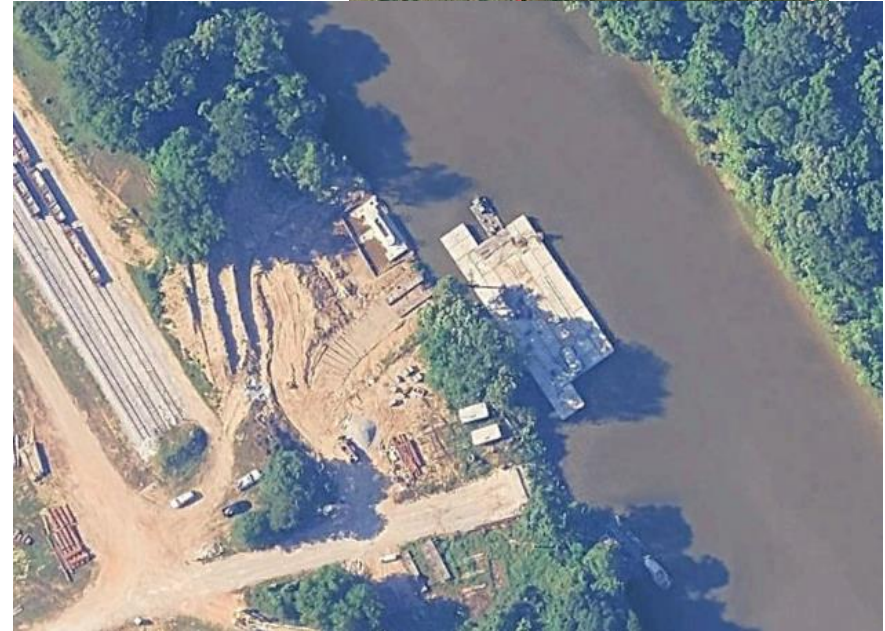
- Pier 2 was struck by a runaway barge in February 2020
- The top of the pier displaced 11”
- The bottom of pier was separated from foundation
- There was cracking throughout the column web-wall near point of impact

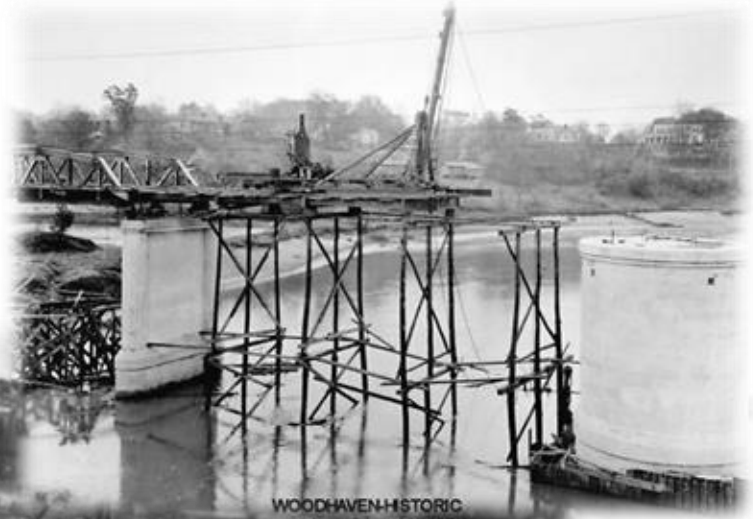
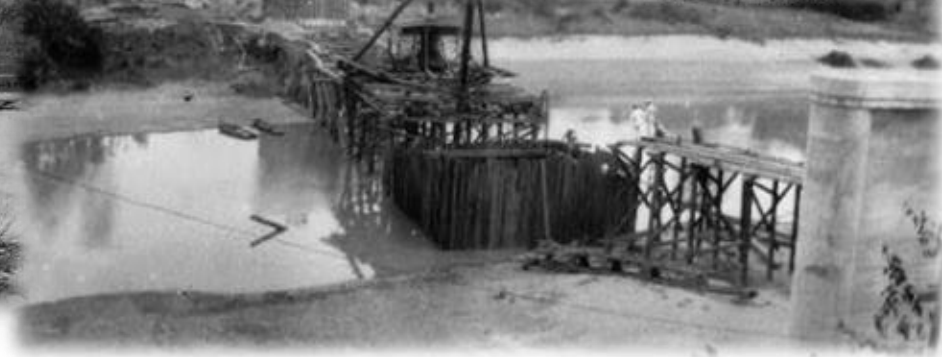
- Opened to traffic in 1927
- 604' total bridge length
- 220' concrete T-beam approach spans
- 90'-102'-102'-90' riveted steel truss river spans
- The two center truss spans were designed to pivot on center pier
- The river piers were constructed on spread footings
- The bridge was added to the National Register of Historic Places in 1988

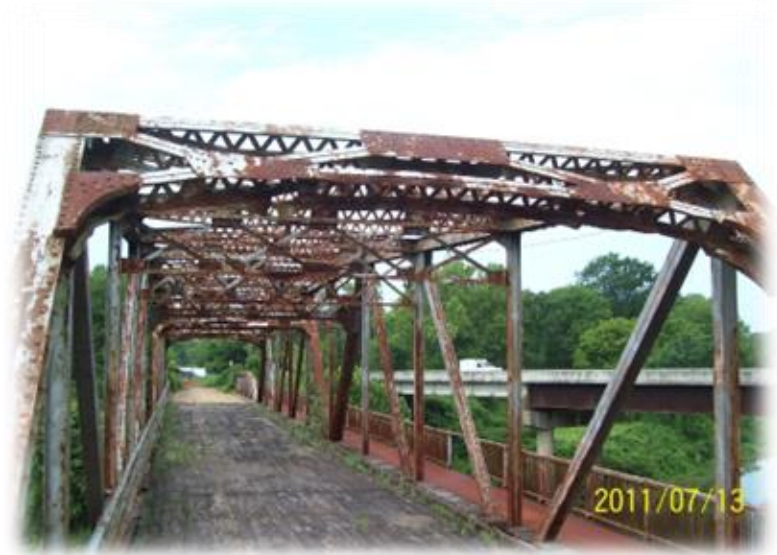
# Bridge History – Pre 2013 Rehab

- A 1989 under water inspection found scour under the center pier which led to the construction of new bridge to the north in 1993
- The bridge was closed to traffic after new bridge opened
- Funds were raised to rehabilitate the bridge for pedestrian use

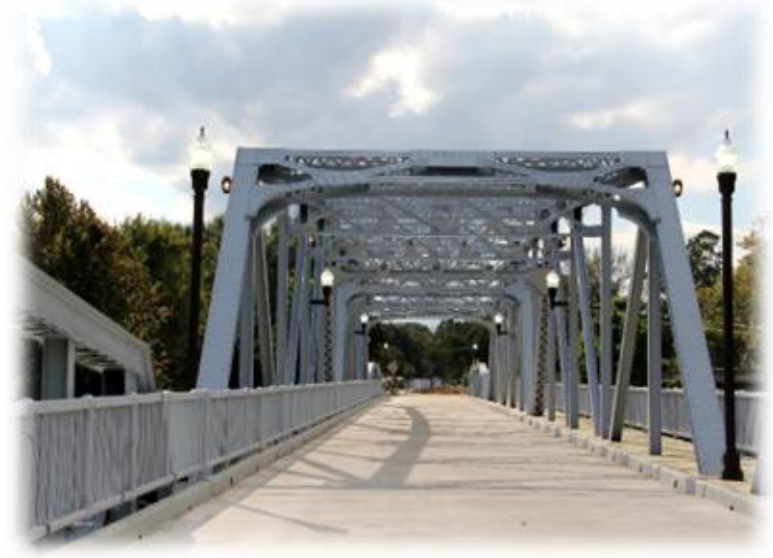
# Bridge History – 2013 Rehab

- Repaired center pier scour
- Replaced timber-asphalt deck with concrete
- Replaced timber sidewalks
- Repaired truss and rails
- Repaired concrete spalls
- Painted
- Added LED lighting
- Malouf Construction, LLC was the general contractor

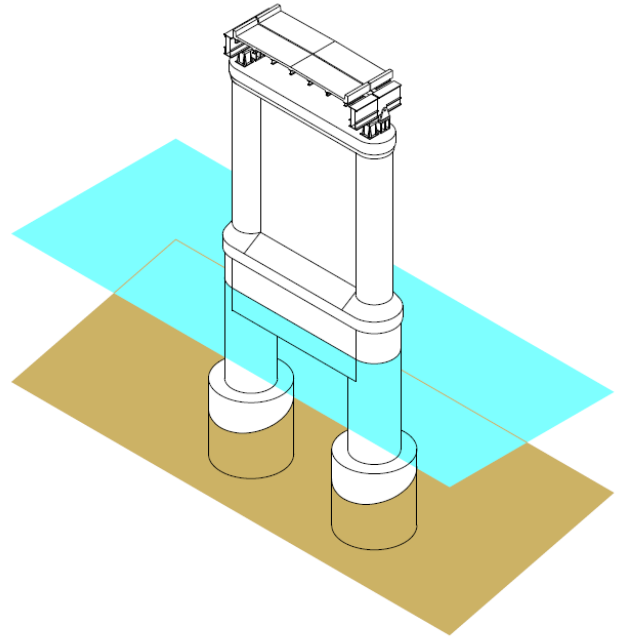
# Hybrid Design-Build

- River piers are supported by 11'Ø spread footings socketed into the hard chalk foundation soil
- The pier has very little reinforcement by today's standards
- 20' water depth
- The Department of Archives and History required that all parts of the pier repair visible above the water must match the existing pier

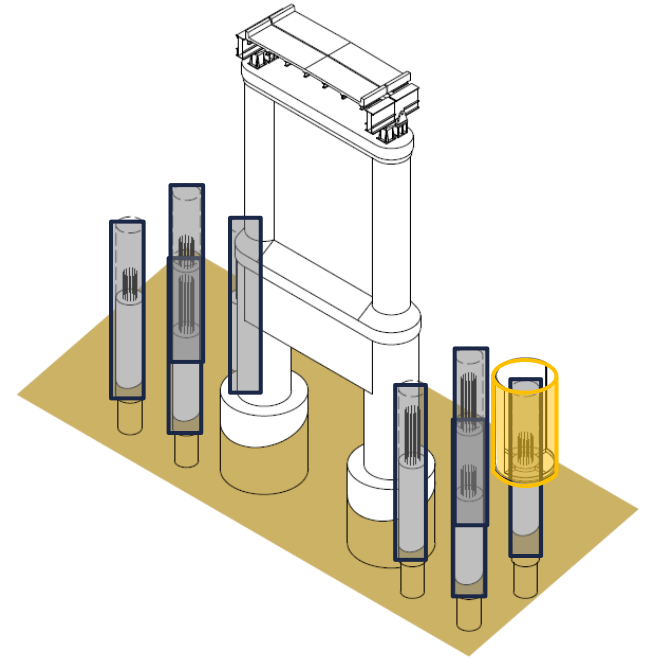
# Drilled Shaft Installation

- 4~36"Ø x 40' drilled shafts on each side of the existing pier
- 42"Ø steel pipe casing embedded 10' into chalk
- 90"Ø pipe with "donut" shape base plate used for cofferdam
- An inflatable bladder connected cofferdam to casing pipe and sealed gaps
- Pipe was dewatered so workers could cut casing pipe and prep top of drilled shaft for caps

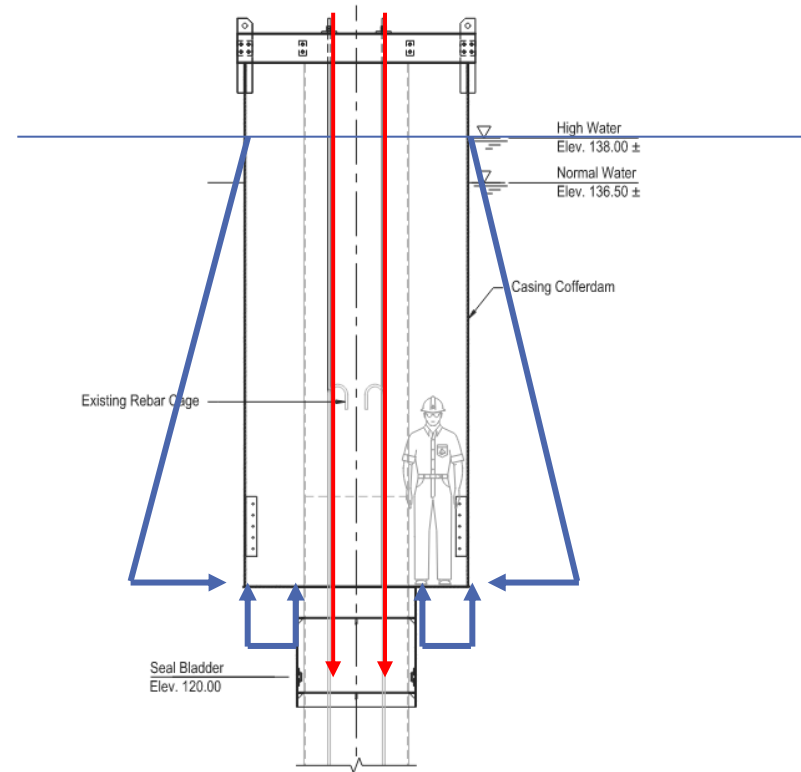
# Drilled Shaft Installation

- 18 ft of hydraulic head
- Produces 40,000 lbs uplift once dewatered
- Needed 2- 1" Dia Hold Down Rods

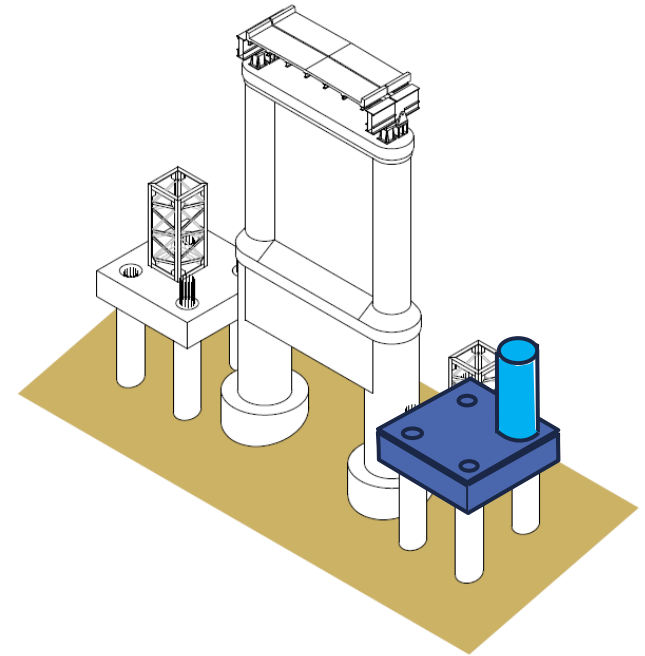
# Precast Shaft Cap Installation

- 16' x 16' x 4' precast drilled shaft caps
- Grout holes constructed over each shaft
- Interior drilled shaft reinforcing extends into second precast component (not shown yet)
- 54"Ø cofferdam pipe used over each grout hole
- Required minimum dewatering to eliminate flotation concerns on cap.
- Cofferdam pipes and first section of shoring towers were installed prior to installation
- Divers guided cap into position and sealed junction
- Grout pockets were dewatered and filled

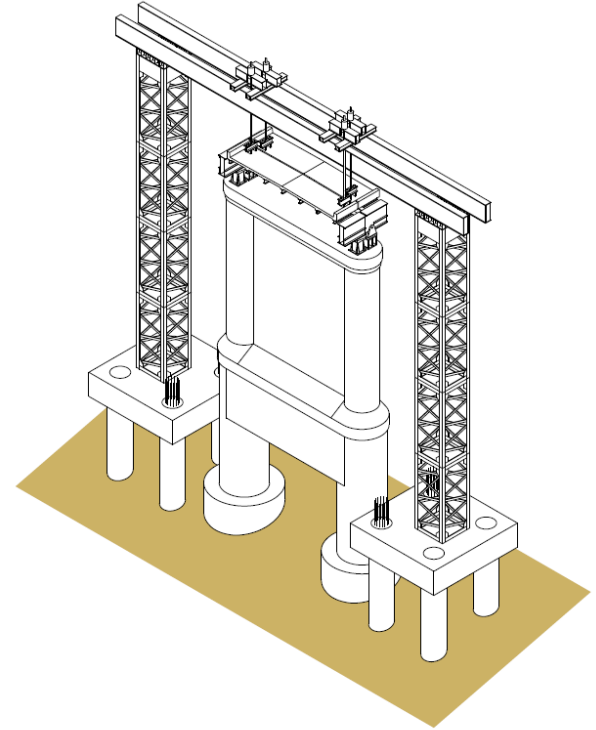
# Shoring Tower Installation

- Shoring tower erection was completed
- Hanger rods were attached around truss end floor beams
- Strand jacks lifted truss spans off pier about 1/2"
- Bearings were removed

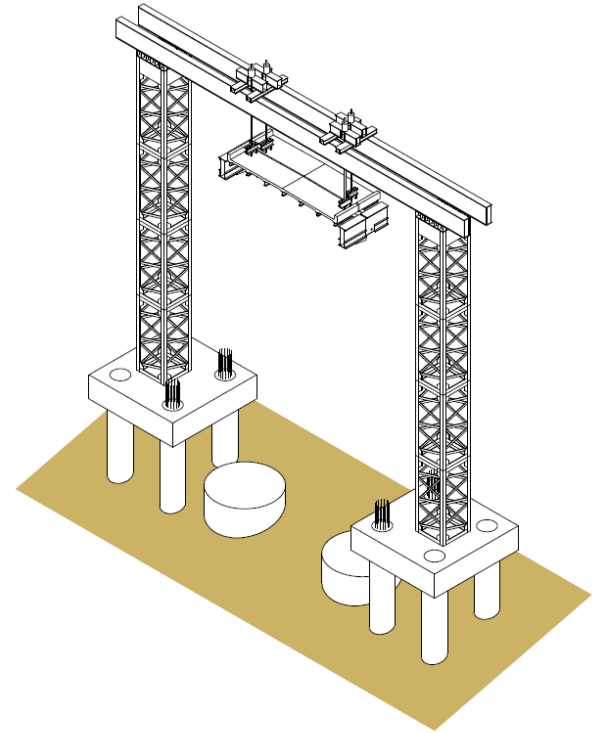
# Existing Pier Demolition

- Existing pier was demolished to top of footing
- Shoring towers supporting the truss spans
- Existing pier demo near completion

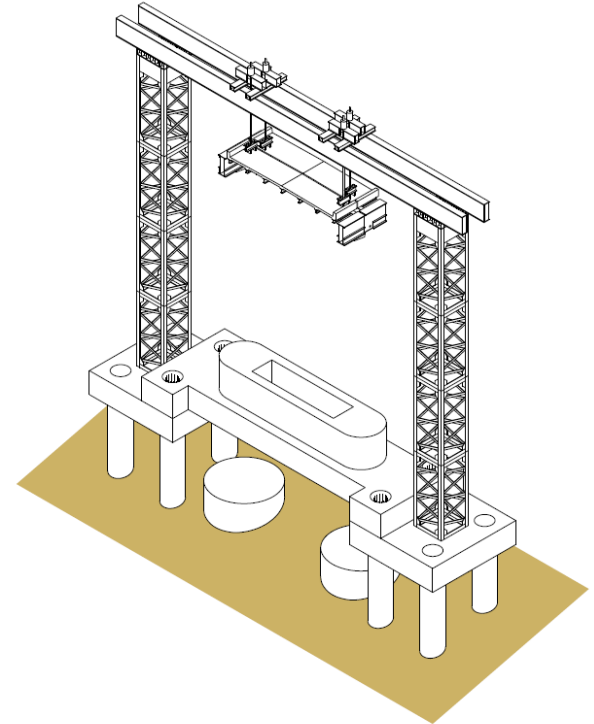
# Precast Riser Installation

- Precast riser was installed between caps over the interior drilled shafts to get construction out of the water
- Top of riser base sits about 1' below normal water surface
- Riser was cast with a center void to reduce weight, yes please!
- Lifting weight was 190 tons

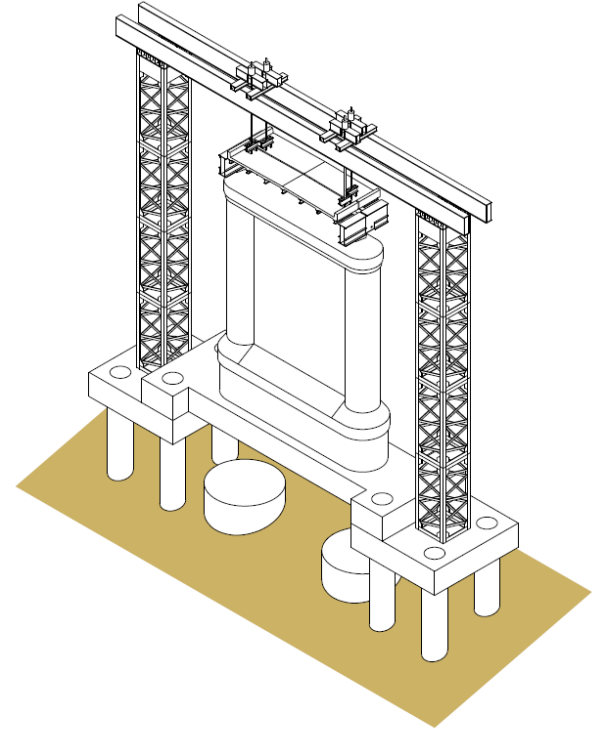
# Cast-In-Place Pier Construction

- Portion of pier above water was cast-in-place using conventional methods
- Bearings were reinstalled
- Truss spans were lowered onto new pier
- Shoring towers were disassembled
- Minor steel repairs, painting and lighting repairs were completed

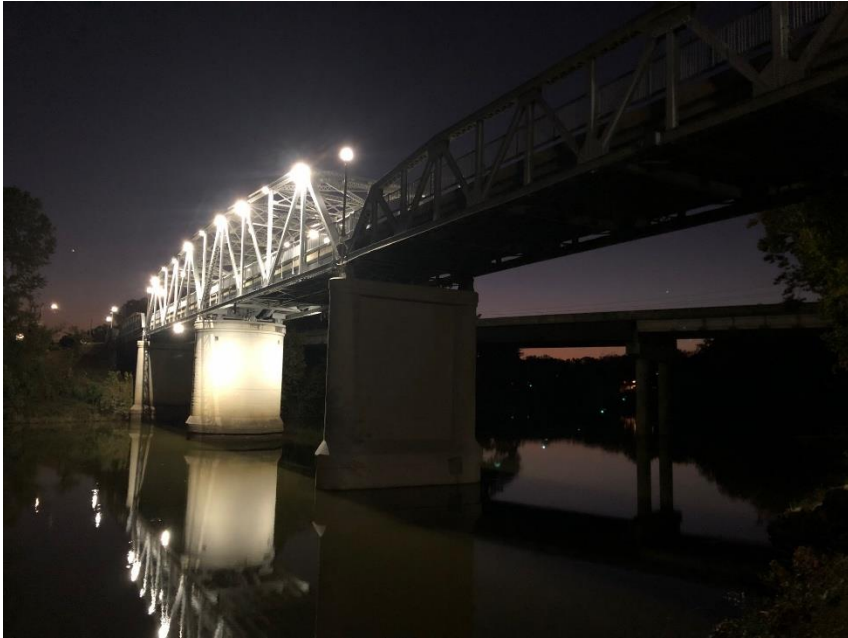
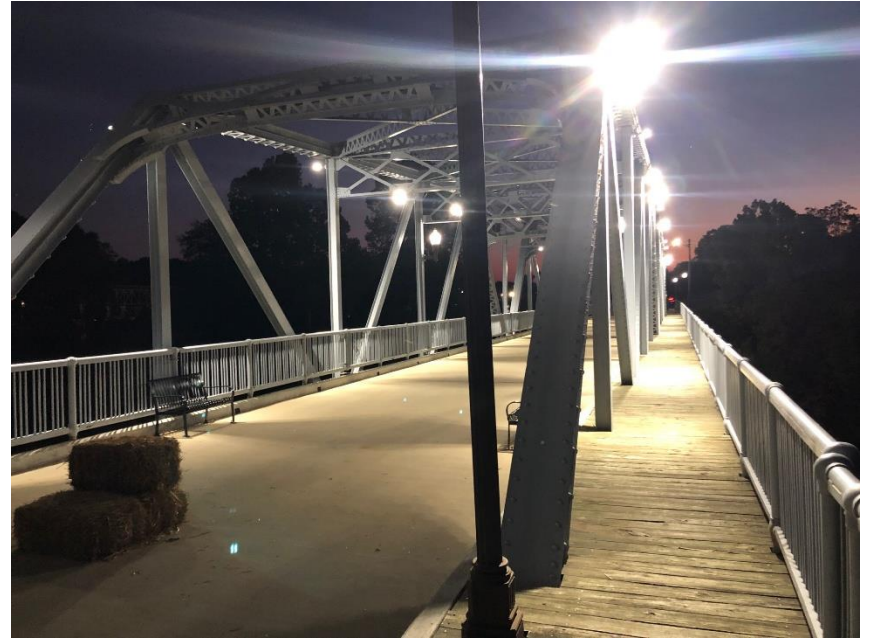
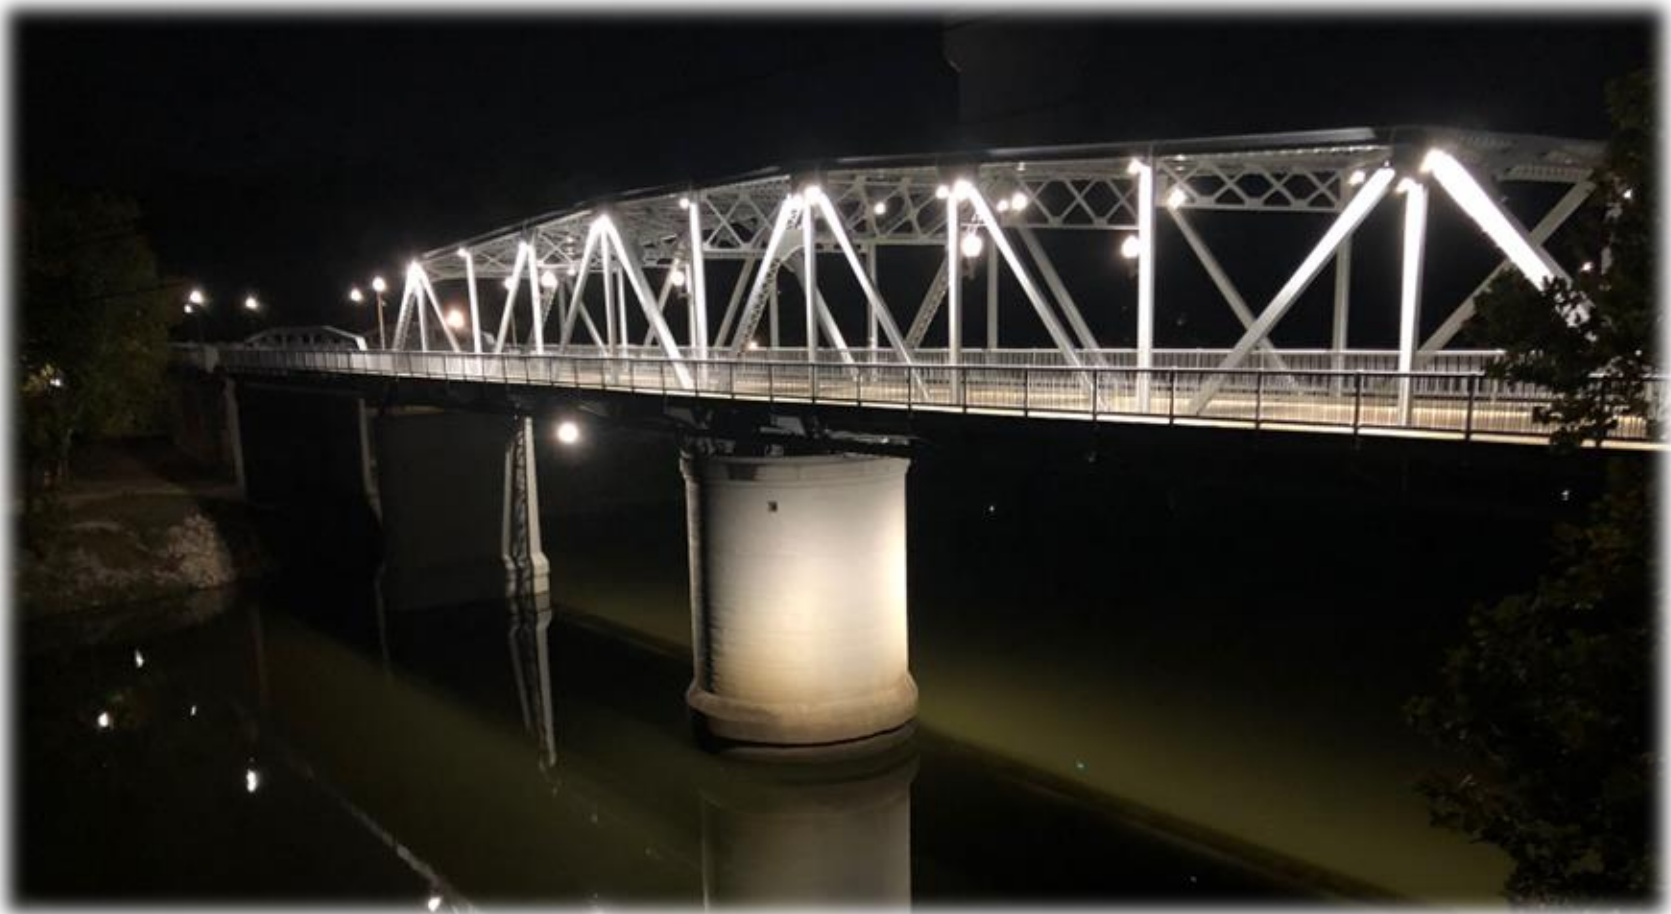
# Completed Reconstruction

- Bridge reopened to the public September 2024
