Repairs to the Historic Tombigbee River Hwy 182 Bridge

JOE KNAPP, Genesis Structures Inc., Kansas City, MO and STEVEN BOWEN, Malouf Construction, Greenville, MS and RANDY BOUDREAUX, Neel-Schaffer, Jackson, MS

IBC 25-10

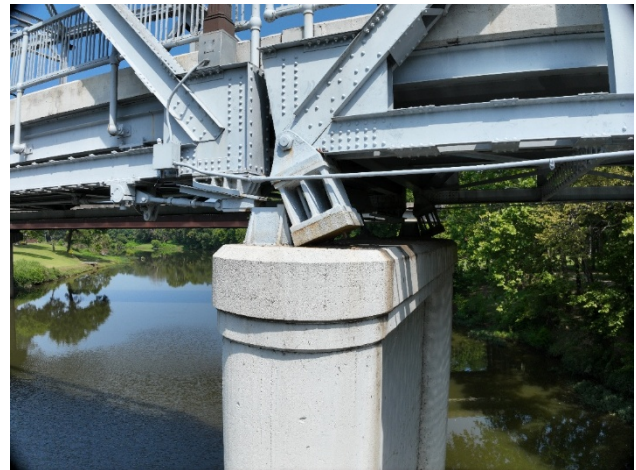
IMG 2 - Damaged Pier

In February of 2020, the bridge was closed again after a runaway barge struck one of the river piers, deflecting the top of the pier 11 inches toward the bank and separating the columns from the foundation. The limited rotation of the bearings on the truss span kept the pier from collapsing. The City of Columbus hired Neel-Schaffer to assess the damage and develop a repair. The primary challenges were:

In addition to the column separation from the footing, the pier had only minor cracking in the web wall between the columns. Therefore, the first option considered was plumbing the existing pier and reattaching the columns to the footings. The water depth at the pier is approximately 20 feet and the repair would likely require a full cofferdam. Driving sheet piles in the stiff chalk foundation soils would not be practical. Instead, the sheet pile installation would require trenching and grouting the piles in place. Also, the internal cofferdam bracing would restrict the work area around the pier. Shoring the bridge on independent foundations would be required prior to beginning the cofferdam. This option was ruled out due to safety concerns over manipulating the existing pier and the cost of the cofferdam.

The design concept chosen was re-building the pier on new foundations outside of the existing footings. This design utilized four cased drilled shafts and precast caps at each end of the pier. The pile caps were attached to the shafts using grout pockets. Next, temporary shoring towers were installed on the precast caps near the outside edge eliminating the need for separate temporary

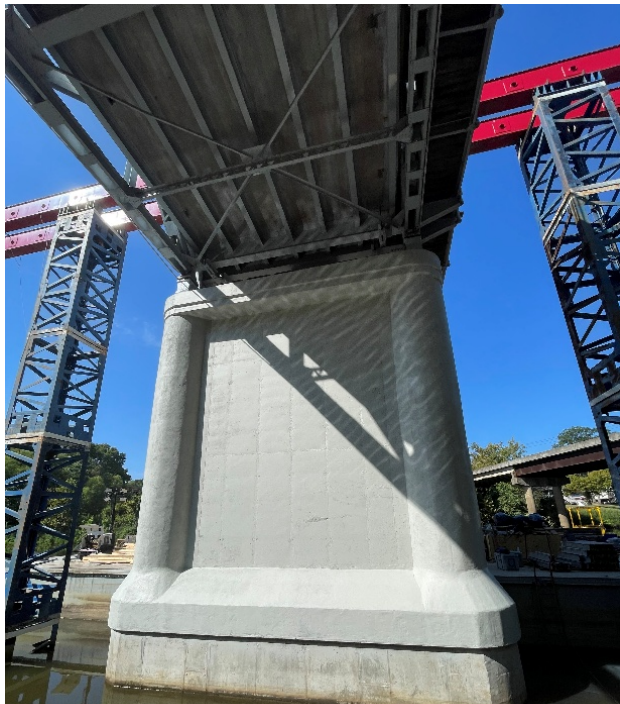
IMG 3 - New Pier

foundations. The temporary shoring tower/gantry system supported the ends of the two trusses that rested on the damaged pier. Once the bridge was supported and the existing pier demolished to the top of the footings, a precast riser that extended the construction above the water was installed near the inside edge of the pile caps. Again, grout pockets were used to attach the riser to the pile caps. For both the pile cap and riser installation, pipe pile coffer-cells were used over each grout pocket to minimize dewatering and allow for the addition of reinforcement between the precast elements and precise grout application. The remainder of the pier was constructed using conventional methods. All visible portions of the new pier above water were visually identical to the original pier.

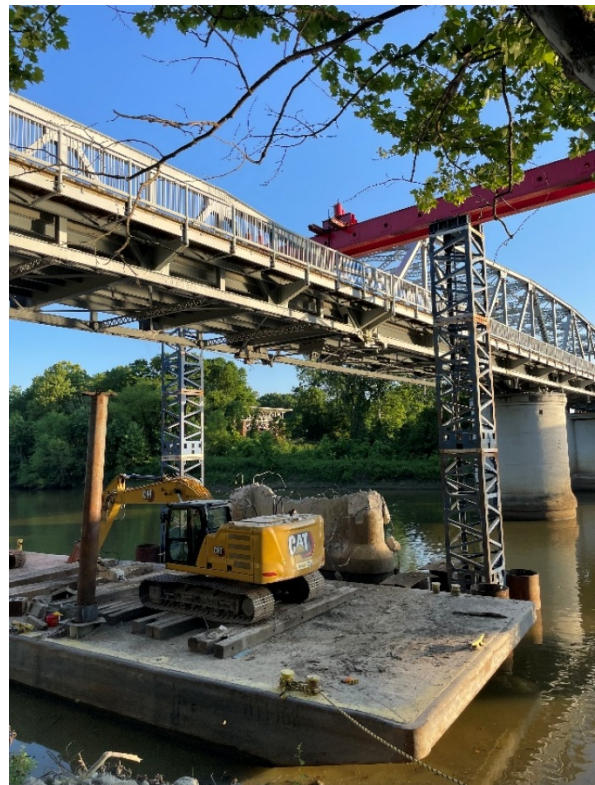
IMG 4 - Spans Supported by Falsework

provided the temporary shoring towers and overhead gantry system to support the existing truss spans. The shoring towers came up approximately 60 feet from the newly constructed pier caps with a double W40 header beam spanning 55 feet from tower to tower. Four center-hole jacks with 1.75" threaded rods engaged the end floor beams of both trusses and lifted the trusses off the damaged pier. Each span required approximately 80,000 lbs of lift force per corner.

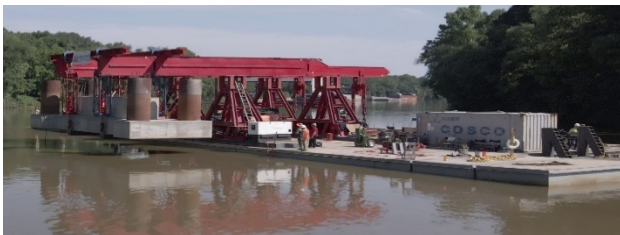
IMG 5 - Hoisted Precast Riser

To hoist the 380,000 lb precast, a Shugart Pontoon barge with a custom Barnhart gantry lift system was used. The barge platform was 120 feet wide by 60 feet in length to allow the barge and precast riser to fit between the existing swing span pivot pier and the falsework towers supporting the spans. Barnhart's gantry system used four 20-foot pyramid shoring stands that elevated two 5-foot-deep box girders that supported four 70-ton strand jacks that cantilevered over the side of the barge 14 feet.

The Barnhart gantry lift system required a rear hold down to resist the overturning effect from the precast cantilevered hoist. A total of 300 kips of hold-down force was required to stabilize the gantry lift system. This was achieved by connecting an attachment frame through the pinhole connections of the Shugart barge to a reaction system under the pontoons. As the load in the strand jacks were systematically increased, a series of pontoons on the stern of the barge were filled with water as counterbalance. Approximately 100,000 gals or 800,000 lbs of water counterweight plus another 80,000 lbs of deck counterweight was used to counterbalance the system.

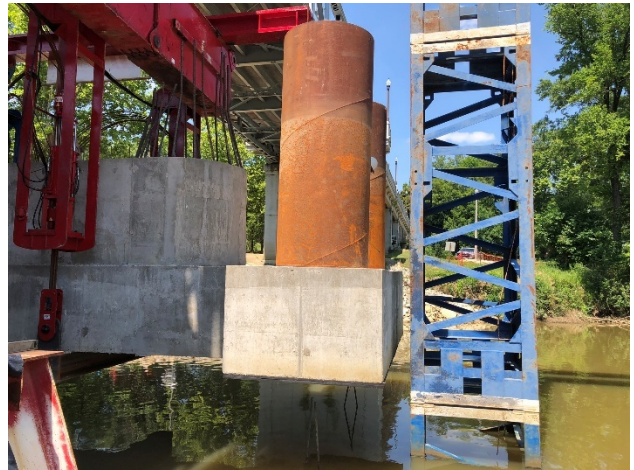
IMG 6 - Tight Clearance

Once the precast was freed from the bank line, the system was floated downstream to the project site. Extreme care had to be provided to ensure the precast would not

impact the falsework towers during final positioning. A minimum of 12" of clearance was maintained during the positioning. A spudded guide barge provided the initial rough alignment and positioning and then hand winches and wire lines in all 4 directions provided the fine movement control. The precast riser was lowered onto the pier caps, and the water ballast was removed from the barge as it continued to transfer its load to the piers.

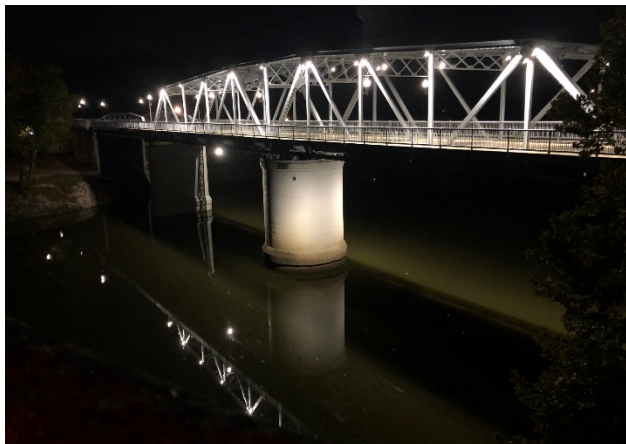
IMG 7 - Completed Bridge

With the precast riser installed, conventional concrete construction continued the pier web wall and cap construction in 3 concrete lifts. The original bearings were reconditioned and reinstalled, and the bridge spans were set back down onto the new pier.
