The Conrail Point-No-Point Bridge Transformation: Replacing a Century-Old Swin Span with a Modern Bascule

BRIAN HILLHOUSE, Genesis Structures Inc., Kansas City, MO, DANIEL POST, George Harms Construction Inc., Newark, NJ

IBC 26-103

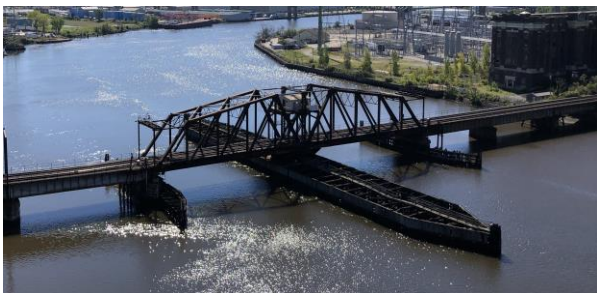
Constructed in 1901, the Point-No-Point (PNP) Bridge provides a critical freight rail connection through northern New Jersey into the Port of New York. At the time of its construction, the bridge consisted of a camelback Howe through-truss swing span that provided two navigable channels across the Passaic River while supporting a significant volume of rail traffic as seen in Figure 1. The structure was supported on stone abutments and piers founded on timber mats and timber piles, reflecting common construction practices of the late nineteenth and early twentieth centuries.

Figure 1 – Original Swing Span

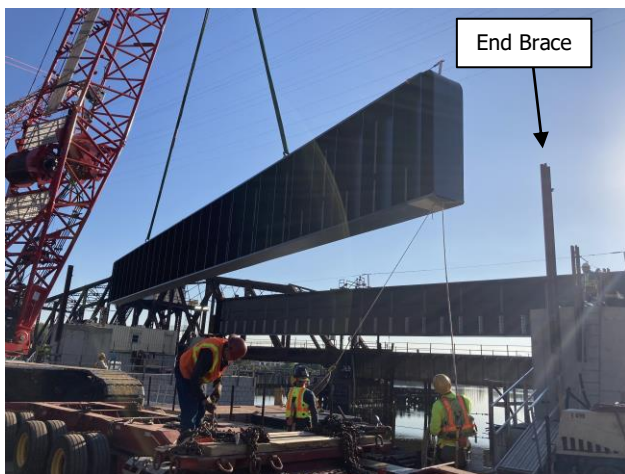
Individual girders were lifted using bolt-on lifting lugs designed specifically for the project. Due to the large depth of the girders, approximately 15 ft, and the relatively narrow width of the supporting piers, temporary end bracing was required to stabilize each girder immediately following erection. These custom bracing assemblies provided lateral stability until floorbeams and diaphragms could be installed to complete the structural framing system. Figure 4 shows the erection of a Span 5 through girder with the temporary end bracing anchored into the side of the pier to provide stability.

Figure 4 – Span 5 Girder Erection

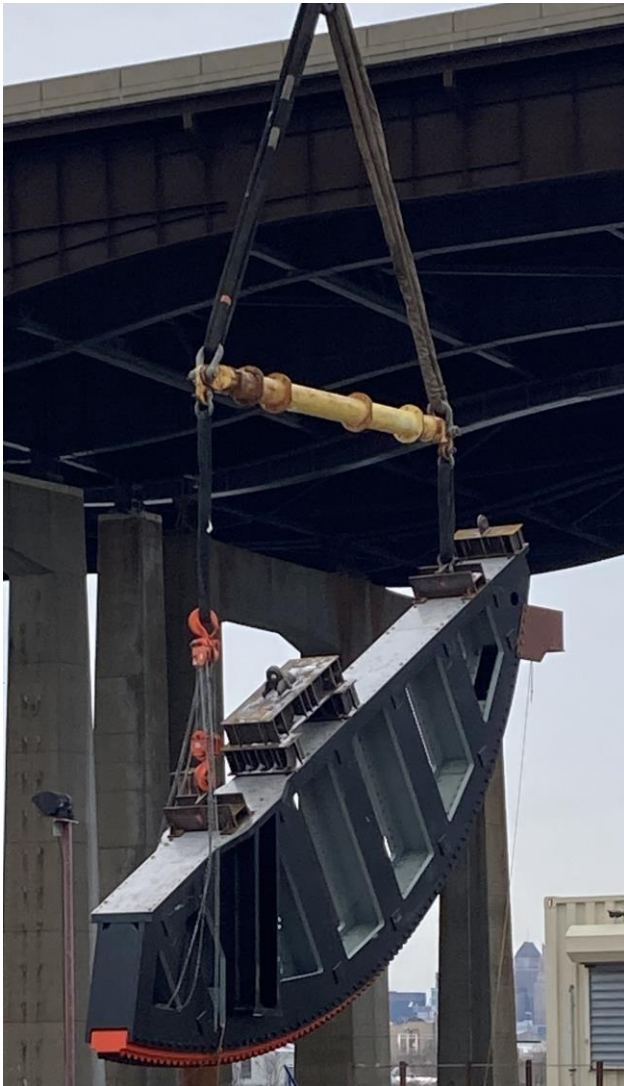
REAR LEAF (BACK SPAN) ERECTION - Erection of the rear leaf began with installation of the gear rack assemblies. Each 105,000 lb gear rack was lifted from delivery trucks using a custom bolt-on lifting assembly designed to allow the component to be rotated from a horizontal shipping configuration to a vertical orientation suitable for installation. Once rotated vertical, a different set of bolt-on lifting assemblies were utilized for final erection. Figure 6 shows the many different bolt-on assemblies that were required to perform this operation.

Figure 6 – Gear Rack Lifting Assemblies (vertical lifting for final erection shown)

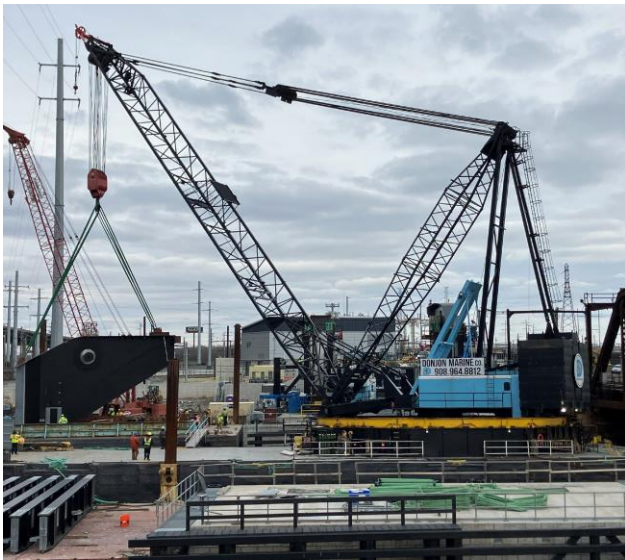
Custom bolt-on lifting lugs and lifting beams were designed for the heel girder erection. Including rigging weight, the anticipated lifting weight of the heel girder was approximately 375 kips. Due to the proximity of the lift to the existing active rail line, Conrail requires that crane lifting operations be designed for 150 percent of the anticipated lift weight, resulting in a design lift weight of approximately 560 kips.

Few cranes were capable of performing this lift at the required radius of approximately 100 ft from a barge platform. As a result, a heavy-lift derrick barge crane was utilized for this operation. The selected crane was a Manitowoc 4600W Series 2 Ringer crane mounted on the Columbia NY heavy lift barge operated by DonJon Marine. The crane was equipped with approximately 760,000 lbs of counterweight and provided lifting capacities of up to 400 short tons over the stern and 310 short tons in revolving configuration. Figure 9 shows the position of the heavy-lift crane barge while erecting the heel girder.

Figure 9 – Heavy Lift Crane Barge Erecting Heel Girder

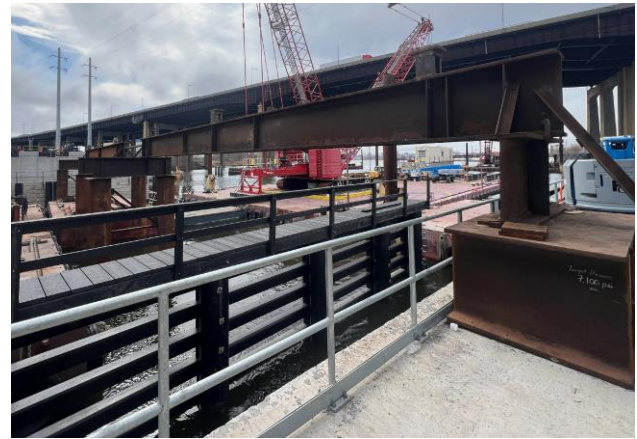
To support the free ends of the floorbeams during this process, a temporary pile-supported structure as seen in Figure 11 was constructed near the tip of the bascule span. This structure consisted of driven piles and a temporary framing system designed to support floorbeam reactions until the second main span girder could be erected.

Figure 11 – Temporary Pile-Driven Support Tower

Due to the earlier heel girder erection operations, which required the heavy lift derrick crane to occupy the space beneath the bascule span, installation of these piles could not occur until the rear leaf erection had been completed. Track stringers installed between floorbeams also utilized milled-to-bear connections, which required additional adjustments during erection. Floorbeams were initially erected slightly flared outward and longitudinally offset from their final position. Track stringers were then installed to gradually pull the floorbeams into their final alignment.

Jacking systems located at the temporary support structure allowed final adjustments to be made prior to installation of the second main span girder.

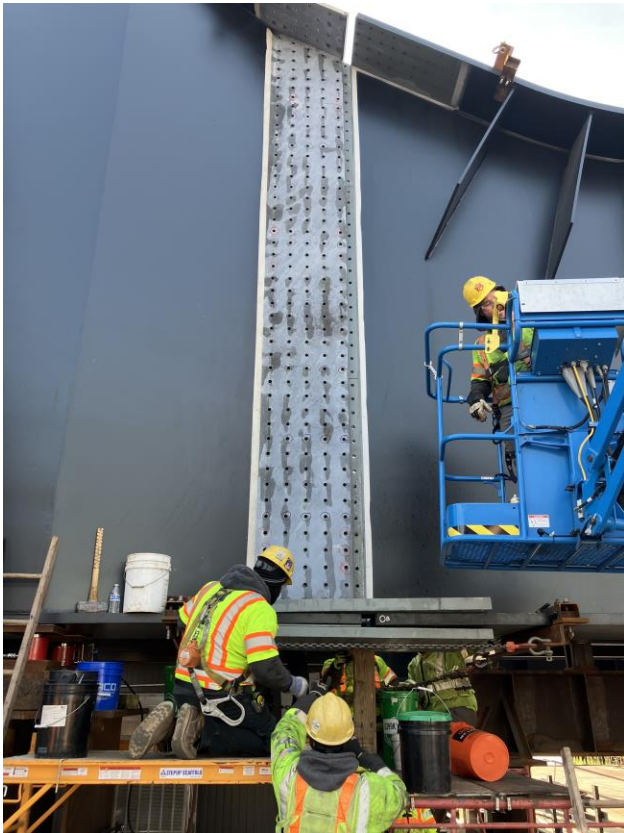
FINAL MAIN SPAN GIRDER INSTALLATION - Installation of the final main span girder presented one of the most challenging aspects of the entire erection process. The splice connection between the main span girder and the heel girder consisted of a unique configuration in which the web of the main span girder passed between the double webs of the heel girder.

This configuration required the girder to be installed using a multi-step maneuver. The girder was first erected in a longitudinally offset position. It was then shifted transversely into alignment with the floorbeam connections before finally being moved longitudinally into its

final position within the heel girder splice. These movements had to be executed while floorbeams with milled-to-bear connections were already installed, resulting in extremely tight tolerances during the final alignment operations. The web splice connection alone contained approximately 220 high-strength bolts, through many plies further increasing the complexity of the installation. The heel girder to main girder field splice during erection is shown in Figure 12.

Figure 12 – Heel to Main Girder Field Splice
