BRIDGE CONDITIONS BEFORE PROJECT

BRIDGE REHABILITATION PROJECT

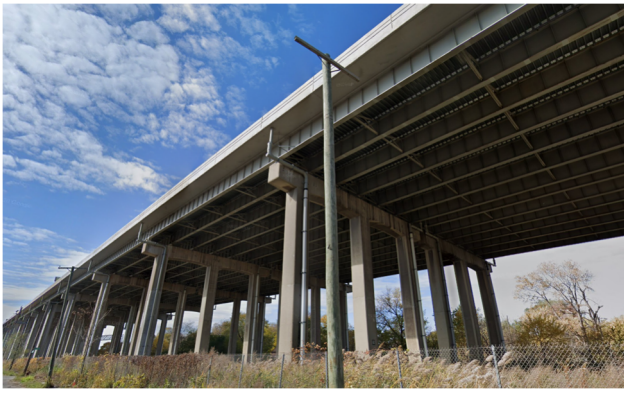
Figure 3 – Sample Spans Elevation

The existing NB and SB bridge structures consist of 106 spans with total length of 8,627 ft. Span lengths vary between minimum 30'-6" and maximum 300'-0" over the Rouge River. The deck width for each bridge is 66'-1 1/2" and each bound consists of four 12'-0" through lanes. Bridges were constructed in 1967 and had several prior rehabilitation projects including placement of latex concrete overlay in the 1970s. Spans are comprised of steel plate girder units and include a variety of configurations including composite deck, continuous units, and pin-and-hanger details included throughout the length.

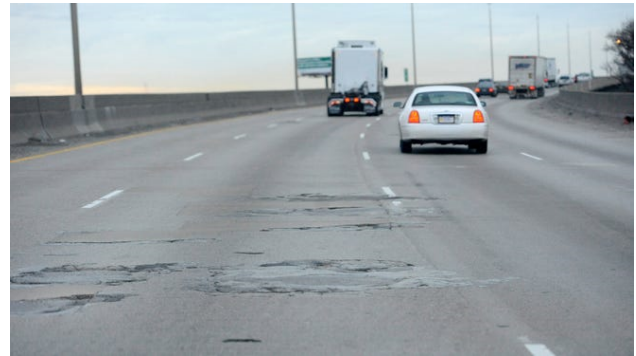
Figure 5 – Deck Conditions Prior to Project

After years of service with heavy traffic usage, the bridge had deteriorated conditions including severe conditions for the concrete deck. In 2015, the bridge was determined to be "Structurally Deficient" due to bridge conditions.

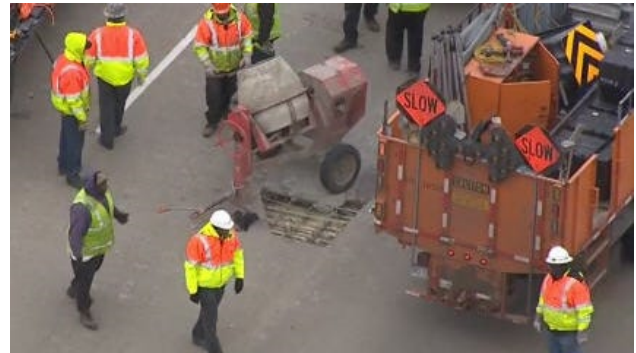
Figure 6 – Deck Repairs Prior to Project

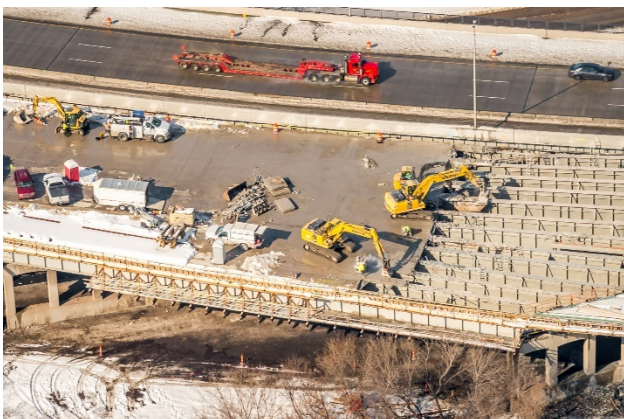
Figure 12 – Equipment during Deck Removal

Deck removal operations were staged and managed to work within the limits and restrictions associated with the evaluation. Based on the scale of the bridge and operation, the management and control of the work was a major effort to coordinate the activities and work of many field staff working together in the operation.

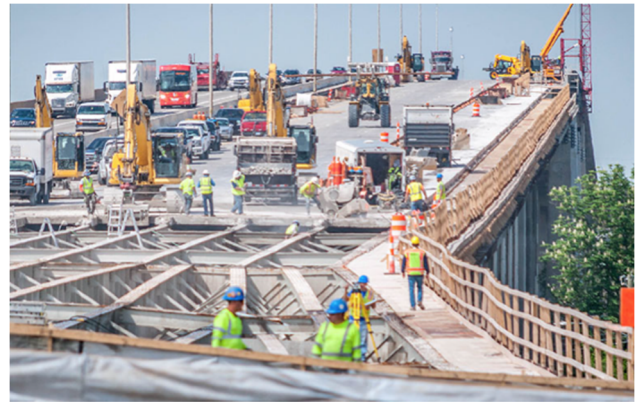
Figure 13 – Deck Removal Operation

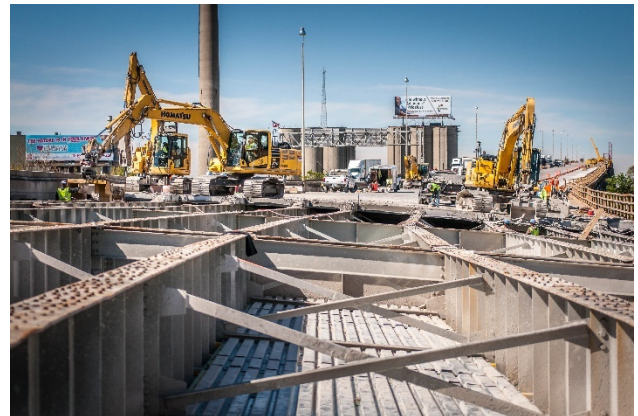
Figure 14 – Deck Removal Operation

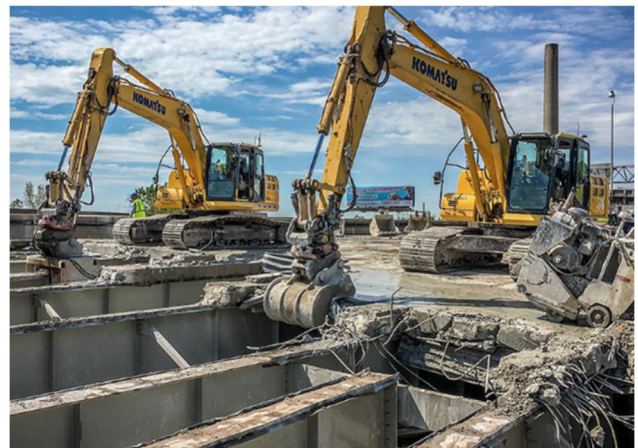
Figure 15 – Deck Removal Operation

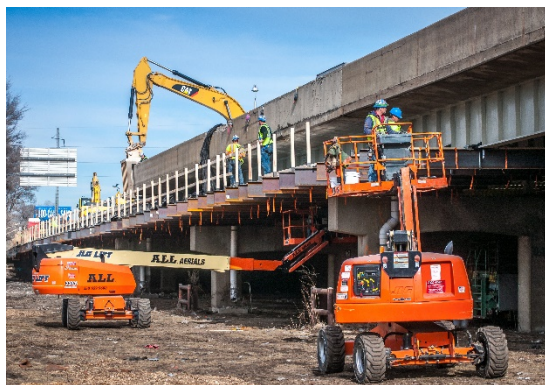
Figure 17 – Fascia Overhang System

Towards that goal, the contractor and engineer developed the Needle Beam System to accommodate demolition false decking as well as provide the vertical support for loading both plastic concrete during placement, as well as finishing machine and concrete conveyor wheel loading. The needle-beams were comprised of various steel shapes and sections, at either 6' or 8' spacing, and were installed using a 210-sized excavator. The excavator featured a rotating attachment at the end of the boom and coordinated with a crew under the bridge in a man basket to install the bolted connections to the bottom flanges of the girders. The excavator attachment was able to rotate 360 degrees, and the contractor added custom hydraulic controls to pinch, manipulate, and release the needle-beam to facilitate installation from the bridge deck. Using multiple live-feed cameras mounted on the excavator boom with display monitors in the cab (as well as simultaneous communication with the crew in the manbasket over radio), the team worked together to swing the needle-beams from the top of the deck under the bridge, fine tune their positioning, and bolt them into place.

For the actual deck forming, a 6"x6" vertical timber and a screw jack were mounted on the top face of the needle-beam. The timber would provide the support for the bottom-of-deck formwork, and the screw jack would allow the contractor to make fine-tuned deck grade adjustments. The timber tied into a horizontal joist that reached from the fascia girder to the outside of the fascia walkway.

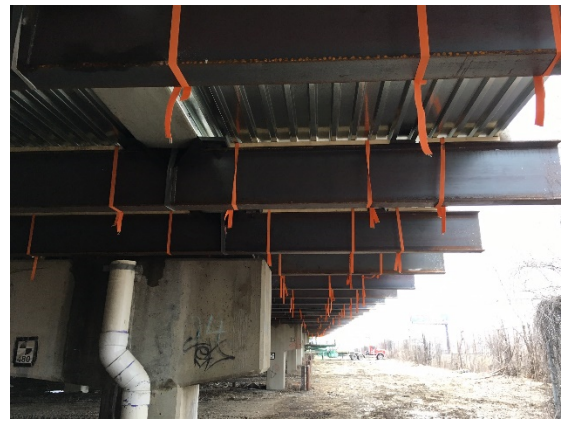
Figure 18 – Fascia Overhang System
