Commonwealth Avenue Replacement Over I-90 and MBTA Commuter Rail

JUSTIN PONTING Walsh Construction Company, Chicago, IL and JOSH CRAIN and DAVID ROGOWSKI, Genesis Structures Inc., Kansas City, MO

IBC 19-8

KEYWORDS: Accelerated Bridge Construction, Plate Girders, SPMT, High Skew Bridges, Design Build Project

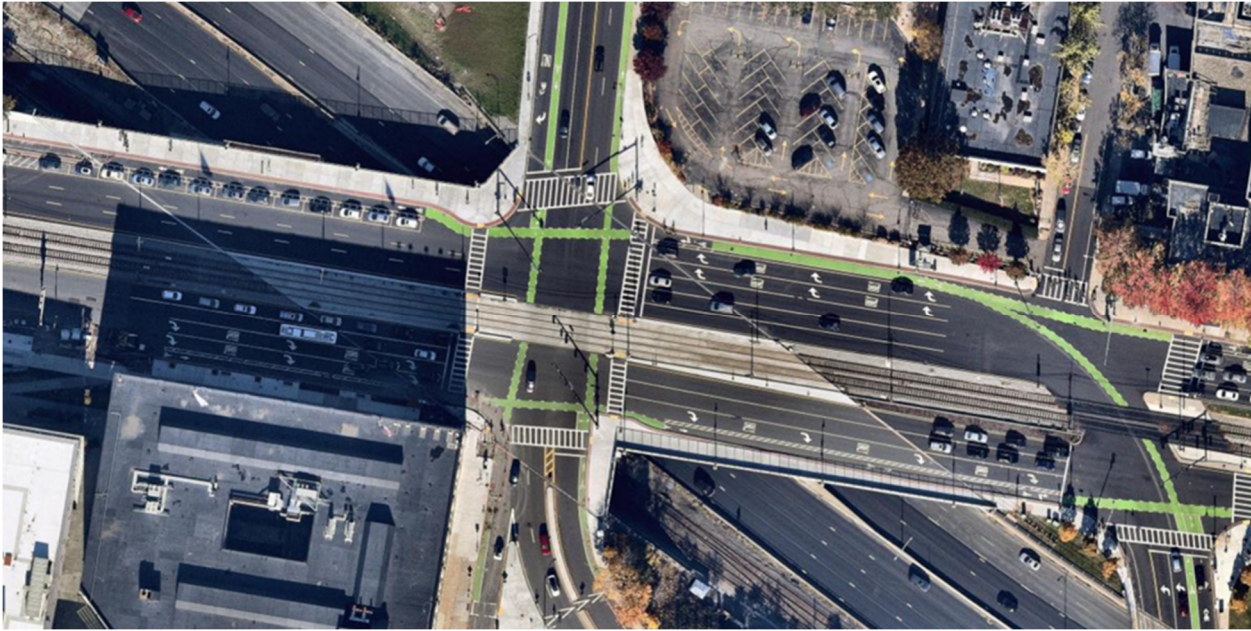
Photo 1 – Plan view of Intersection Between Commonwealth Avenue Bridge / I-90 / MBTA Commuter Rail

Along with carrying the busy Commonwealth Avenue and Greenline traffic, the bridge serves as a popular route for pedestrians that commute and attend nearby colleges (See Photo 1). This traffic is all in addition to the I-90 traffic under the bridge which carries on average 144,000 vehicles daily.

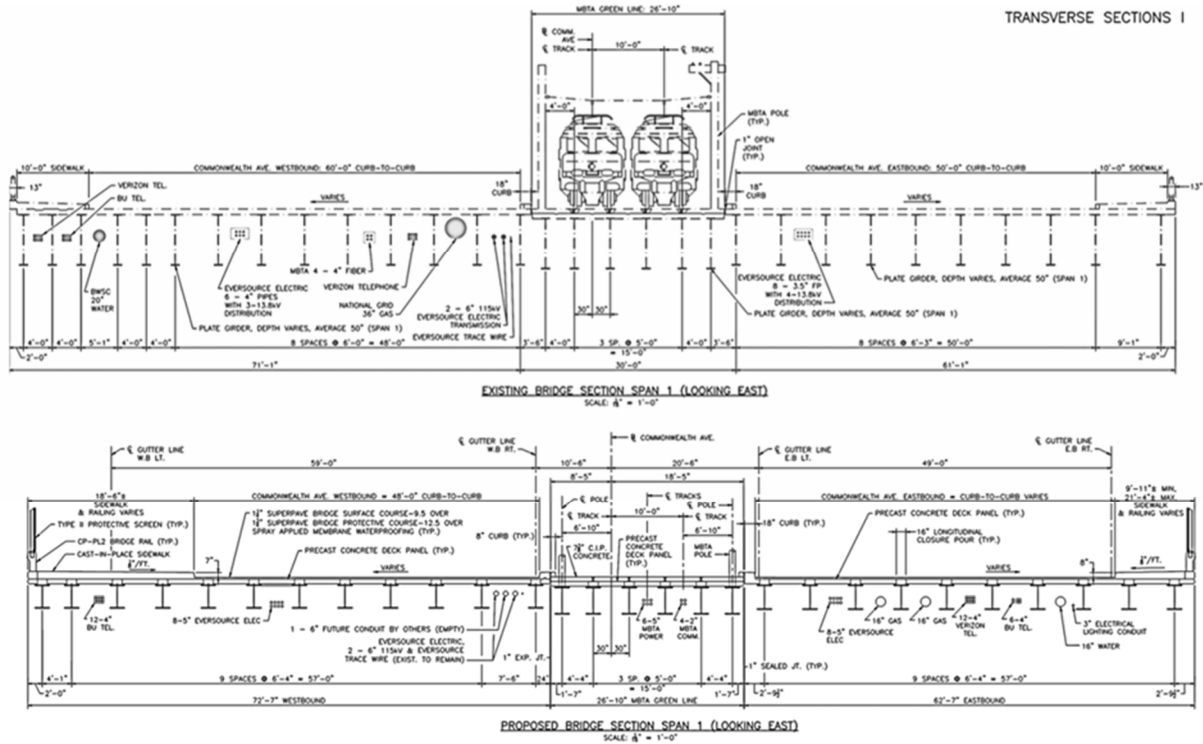
Photo 2 - Transverse section of Existing and New Superstructure

In addition to traffic congestion and overall complexity, 5 different utilities ran through, and were supported by, the existing bridge structure. Support of the utilities complicated both the outage schedule and new structure cross-frame detailing which required unique details to accommodate each different utility type (See Photo 2).

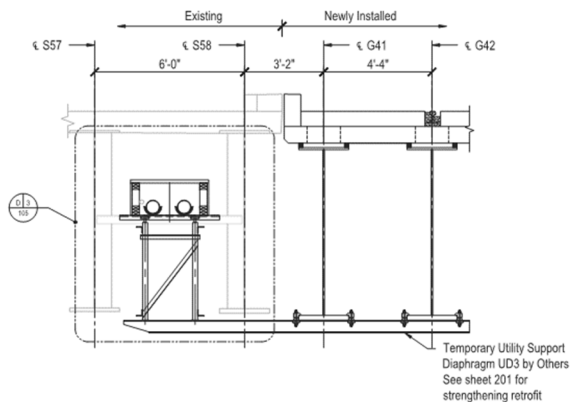
Photo 3 - Detail of Temporary KV Line Support

The most challenging obstacles were 2-115kV oil cooled lines located between the westbound Commonwealth Avenue and Green Line structures. These lines could not be relocated, nor could they be de-energized. The lines had to be protected throughout all demolition operations. During the girder removal and erection, the lines had to be temporarily supported and shielded. The back walls around the line were hand demo-ed, and the backwall sections had to be cast in place during the second outage. Supporting the lines came after the first outage when the Green Line Track girders were replaced. Supports cantilevered off the girders under the bridge and vertical supports went up to carry the lines (See Photo 3)

It was important to get the temporary support in place and to remove the existing utility brackets. This would allow the lines to be only connected to the Green line bridge and not reacting with the demolition operations performed westbound bridge.

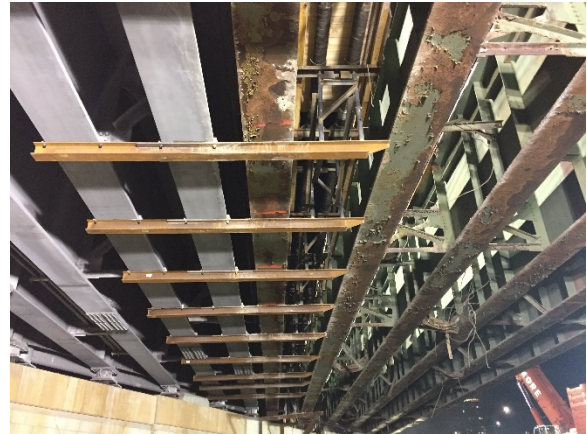
Photo 4 – 115kV Temporary Supports After Deck Removal

As the supports were installed the deck above the kV lines was removed by a controlled saw cutting and slabbing operation (See Photo 4). This saved a huge amount of time during the outage and allowed the utility company to make necessary repairs to the lines prior to the outage.

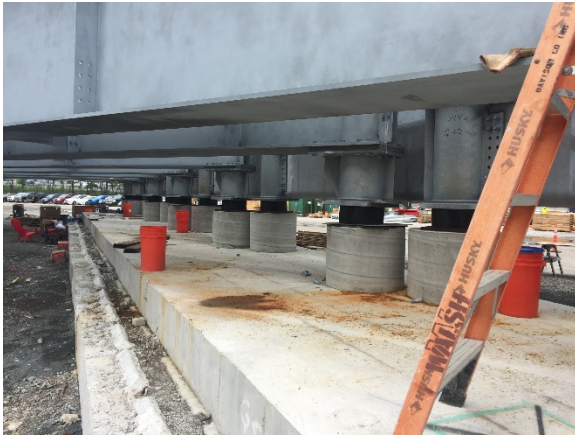
Photo 5 - Temporary Footings and Pedestals at Staging Yard

The project team concluded, the best way to ensure a smooth and efficient steel erection during the outages was to completely build out each span of the bridge prior to the outages at an offsite location (See Photo 6). Temporary concrete footings and pedestals were built at the staging yard to ensure consistency between yard elevations and elevations anticipated on the caps of the existing piers during the outages (See Photo 5).

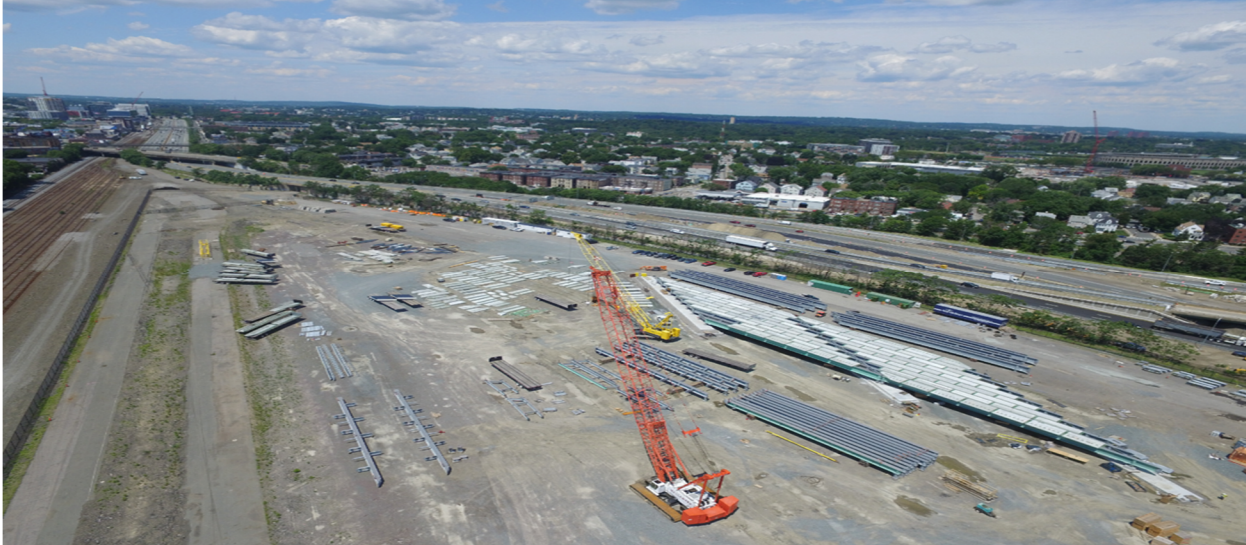
Photo 6 – Pre-Assembled Bridge in Staging Yard

In the staging yard, the girders were paired with cross-frames that were detailed to a total dead load fit which gave them a temporary rotation/twist. The precast panels were then set on top of the pairs, rotating them into the final total load configuration. Then with the deck still in place, the holes in the cross-frame connections between the pairs were field drilled to the rotated shape.

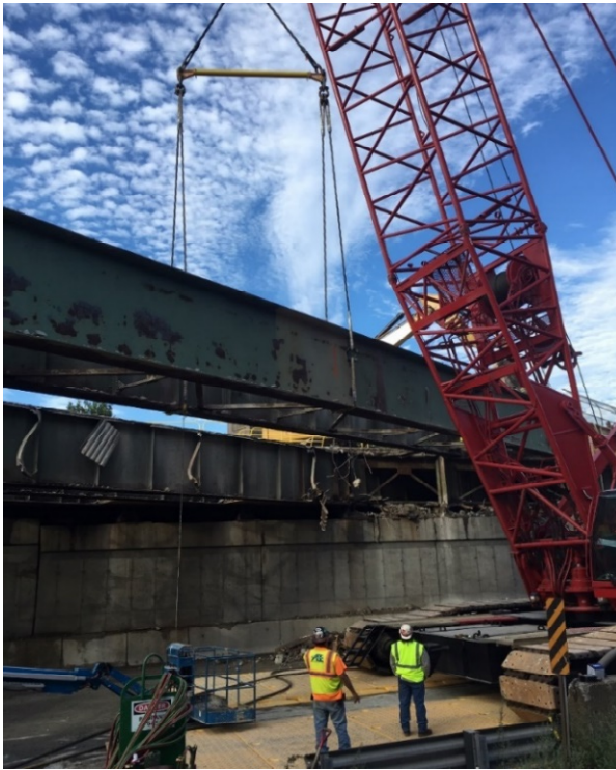
Photo 10 - Removal of Existing Span 2 Girders as Pairs during the First Outage

between other spans, existing girders picked out of level were a problem. After the first girder pair was hoisted, the original plan centers of gravity were verified or changed in accord with the structural elements the demolition contractor was able to remove prior to hoisting. That experience offered valuable information for pre-planning prior to the second outage.

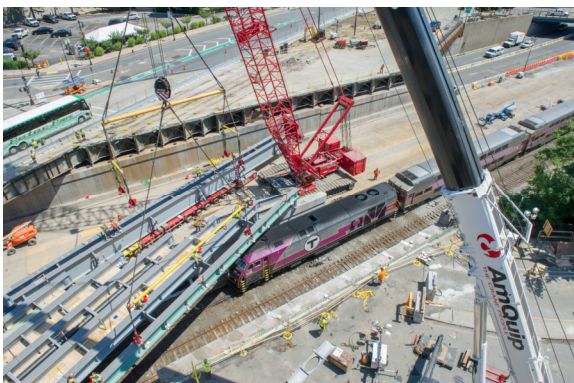
Photo 11- Span 1 Girders Set as Singles

Span 1 installation of new girders was much like the removal. Girders were set as singles at the same

skew. Therefore, all three cranes used for removal were reused for setting. The girders were hoisted with the cross-frames and diaphragms attached, and with the utilities on some of the girders as well. Pre-planning really helped to speed up the erection process and the re-installation of utilities.

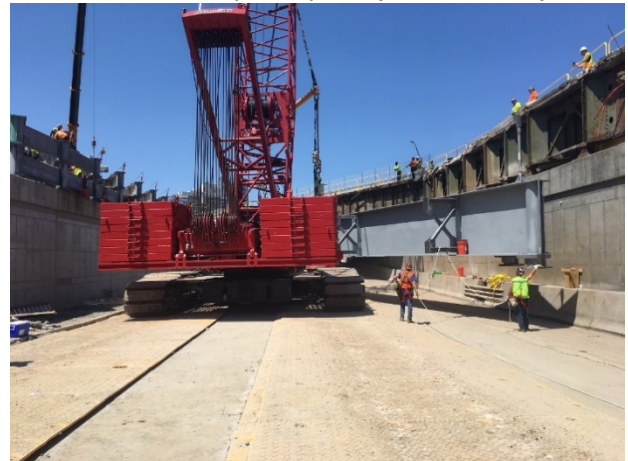
Photo 12 – 400 Ton Manitowoc Crawler Crane in I-90 during the First Outage

Span 2 installation was done in pairs like the demolition. The crawler had to walk to the south end of the bridge, lift a pair of girders off the SPMT's, lift the pair to clear the existing structure, and walk up to 140 feet to erect the pair. The new girder pairs weighed from 130kips to 182kips. The biggest challenge in erecting these girders was a space impediment discovered between the span 3 existing girders and the location of the new span 2 bearings and girders. The span 3 girders had to be blocked up at the bearings, and portions of the existing bearings, flanges, and end diaphragms had to be removed to gain sufficient clearance for installation of the span 2 pairs (See Photo 12).

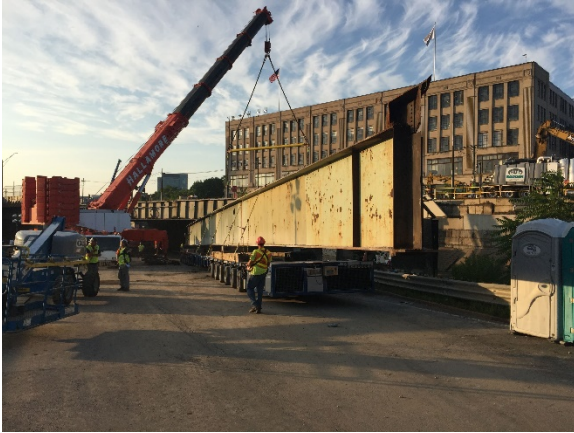
Photo 13 - SMPT Loaded with Girder during Outage 2 to be Transported to Processing Location

With the hydraulic cranes, the demo processing of the existing girders became more complex. The cranes had to be worked in a tight radius and could not cast the girders outside of the existing backwalls in any location to be processed. The solution was to bring in an additional SPMT used strictly for loading demo-ed girders and transporting the girders to a separate area to be processed. The processing area had a another 250-ton hydraulic crane that unloaded the girders from the SPMT. The SPMT then traveled back to the bridge so the cycle could be repeated. (See Photo 13).

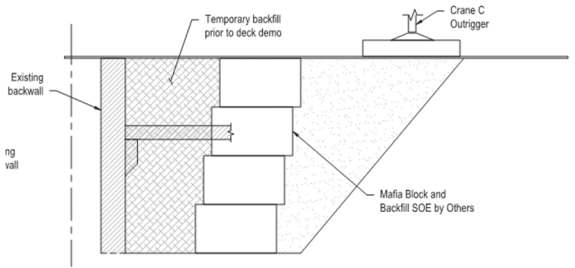
Photo 14 - Drawing of SOE Wall Near Abutments

The 2018 utility and backwall work was much the same as the first outage. A shoring wall was engineered and constructed using 3-ft x 3-ft x 5-ft concrete blocks to set behind the backwall. That allowed for access to remove, erect, and CIP the backwall section.

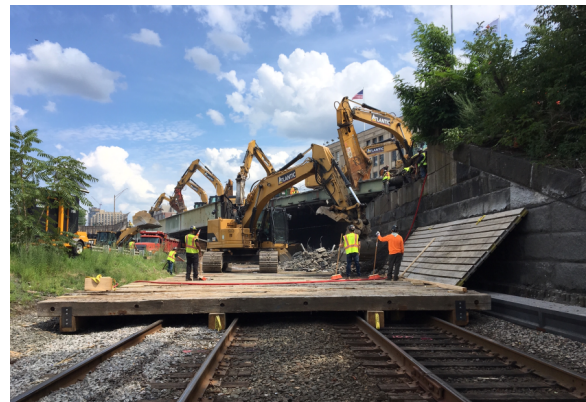
Photo 15 – Track Protection over MBTA Commuter Rail Line

At 1:00 a.m. on Friday the 27th the commuter rail was shutdown. And the track shielding operation to begin. Two high-rail fork lifts were used to install the mats over the top of the commuter rail tracks. A total of 70 mats were used to stretch 210 feet over the rail. All the truck loads of mats were on top of Comm. Ave. and lowered to the commuter rail directly on to the fork lifts, then carried under the bridge to be set (See Photo 15).

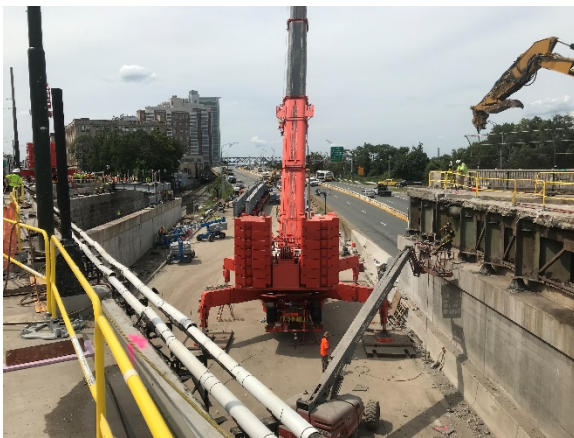
Photo 16 – 600 Ton Mobile Crane in I-90 during Outage 2 Setting New Girder Around Live KV Lines

at a time. The 60-degree skew complicated crane operations. The 600-ton crane had to work in a specific sequence to remove two girders then breakdown and reposition. Then remove three girders breakdown and reposition. Then removing the four remaining girders on span 1, and three girders from span 2 then breakdown and reposition. The last two girders in spans 1 and 2 bookended the 115kV lines. A great amount of time was spent on confirming the girder CG's to ensure a level pick while working around the kV lines. There was only one shot to get them picked correctly. (See Photo 16 and Photo 17)

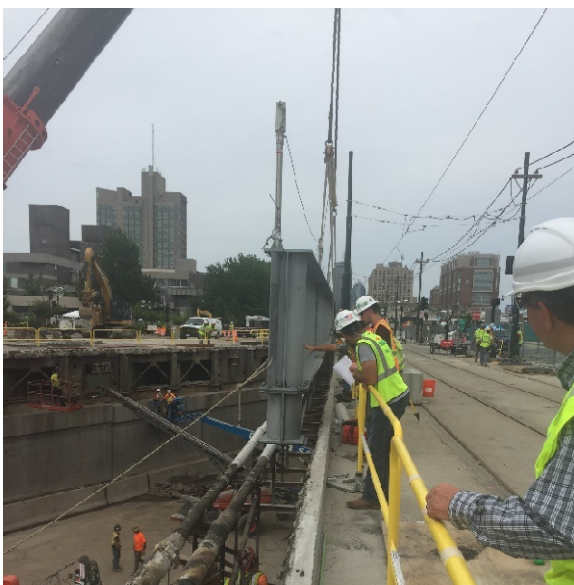
Photo 17 - New Girder Set Around Live KV Lines during Outage 2
